# iPhone 7 - U3101 Audio IC Replacement

Written By: Alexandre Isaac

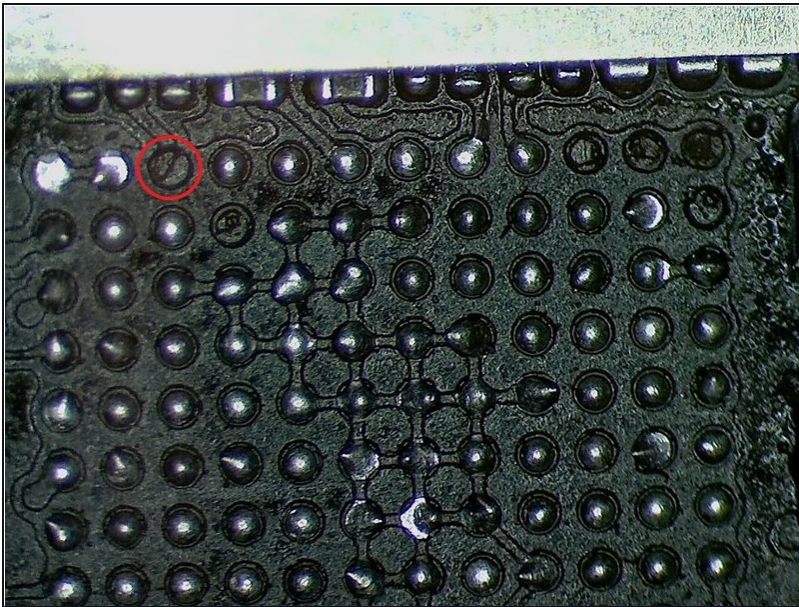
## Step 1 — Remove U3101

**The problem:** The audio chip U3101 is disconnected from the logic board. The iPhone 7's logic board may be slightly twisted and often results in a broken track.

- Remove the chip cleanly, with hot air. On my Quick 861DE rework station, I use the settings 400 °C and 100L/min. For you to decide which settings you prefer, you can find the Quick 861DW on the shop.
- Clean the tracks with a soldering iron, tin and flux. I use a tip about 1mm in diameter with my JBC Nase 2C, at 360 ° C.
- Clean the map.
- Inspect the card under the microscope. We can see on the picture that a track is missing!
