Amazon Echo Dot 2nd Generation Ribbon Cable Replacement

Replace the ribbon cable in the Amazon Echo Dot 2nd generation.

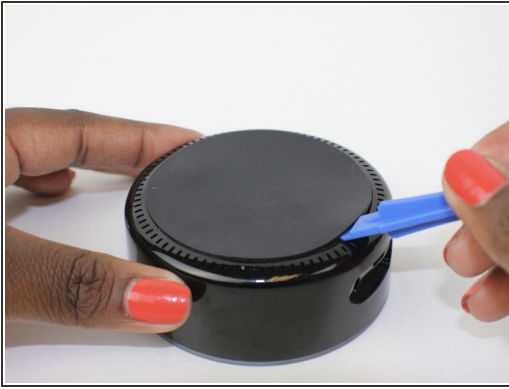
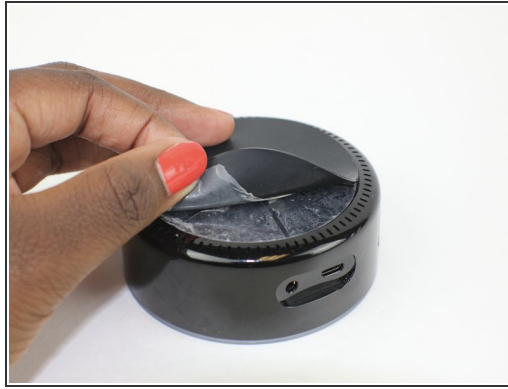
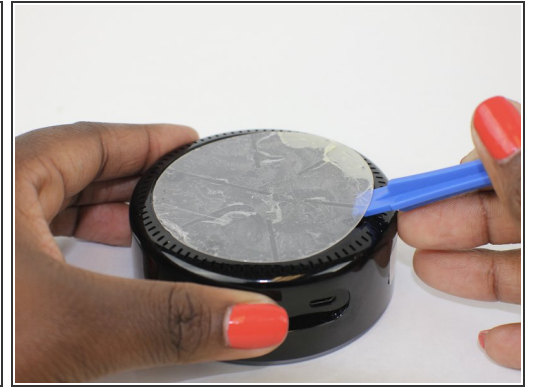
Step 1 — Ribbon Cable

- Power off and unplug the echo
- Using the plastic opening tool, peel off the rubber layer on the bottom of the echo

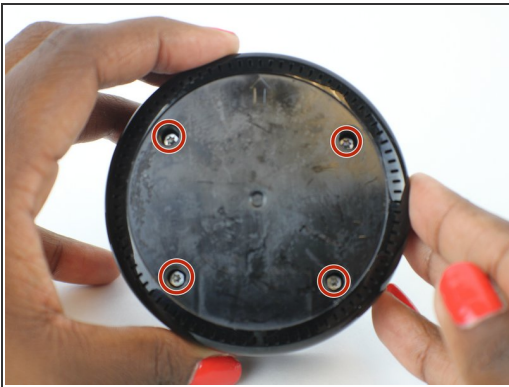
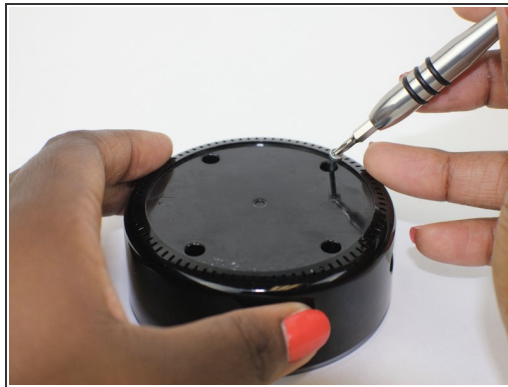
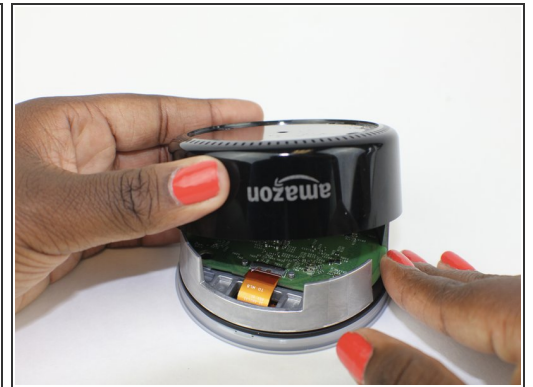
Step 2

- Use a T8 screwdriver bit to unscrew the 1.6mm four screws.
- Remove the black cylindrical base

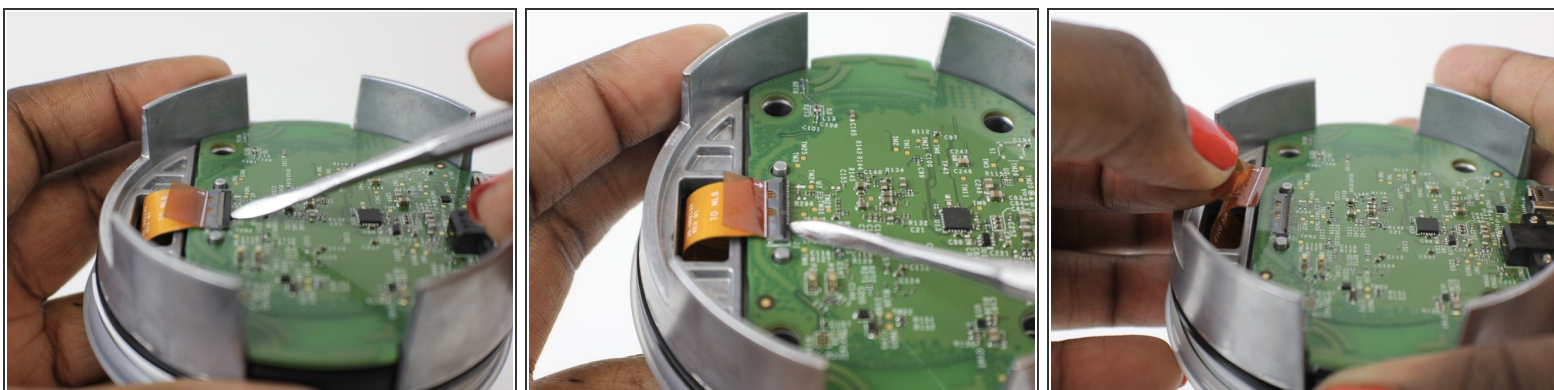
Step 3

- Use the metal spudger to lift the ZIF connector
- Remove the ribbon cable from the slot

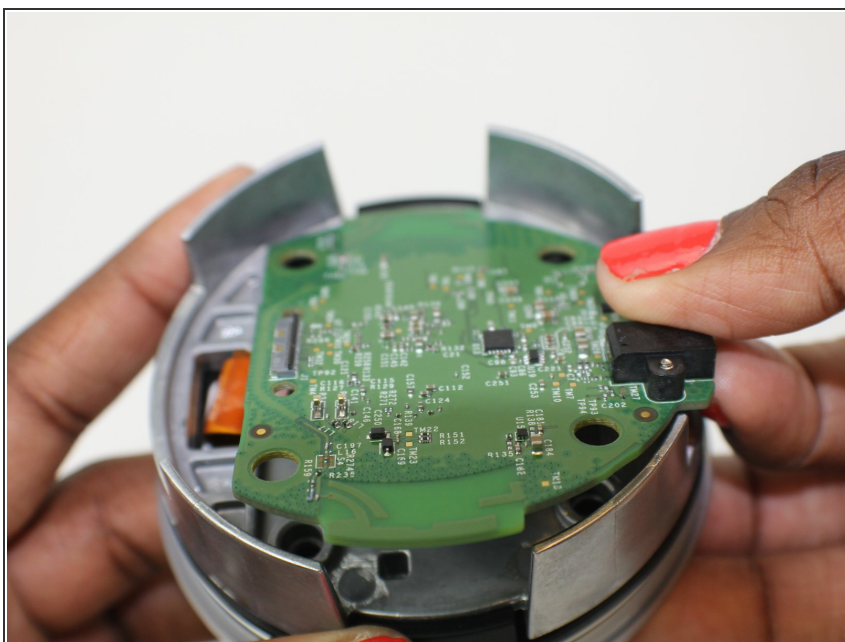
Step 4

- Remove the motherboard

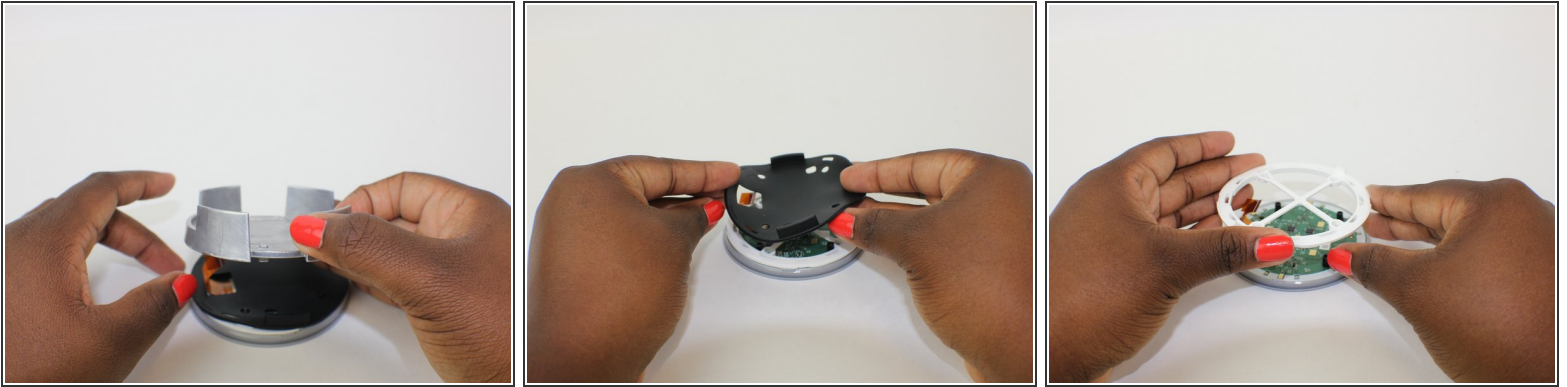
Step 5

- Remove the silver divider
- Remove the black rubber divider
- Remove the plastic white frame

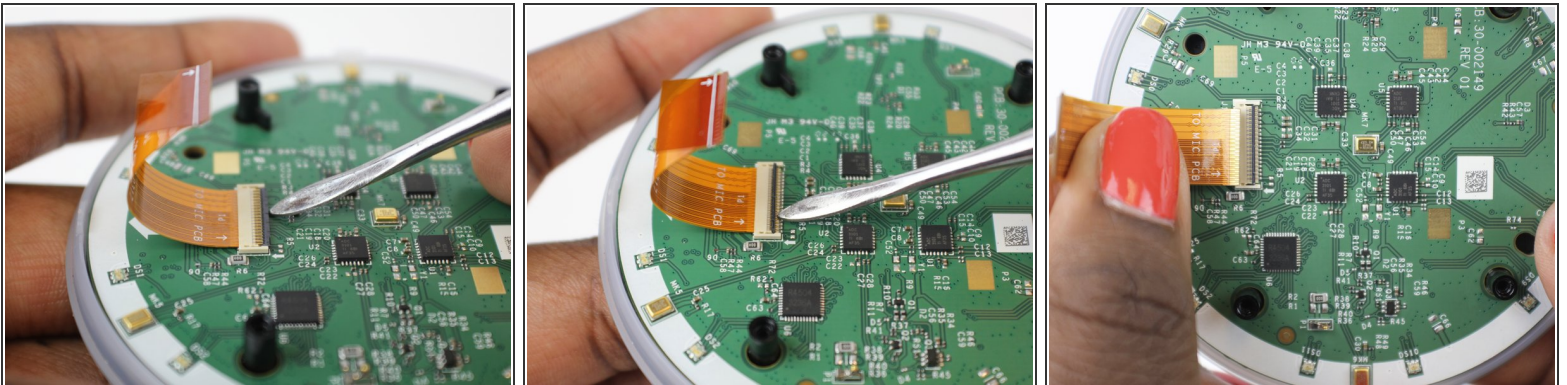
Step 6

- Use the metal spudger to lift the ZIF connector
- Remove the ribbon cable from the slot on the LED/speaker board
