ASUS X552LAV-BBI5N08 CD Drive Replacement

This guide will show you how to replace the CD drive for a ASUS X552LAV-BBI5N08 laptop.

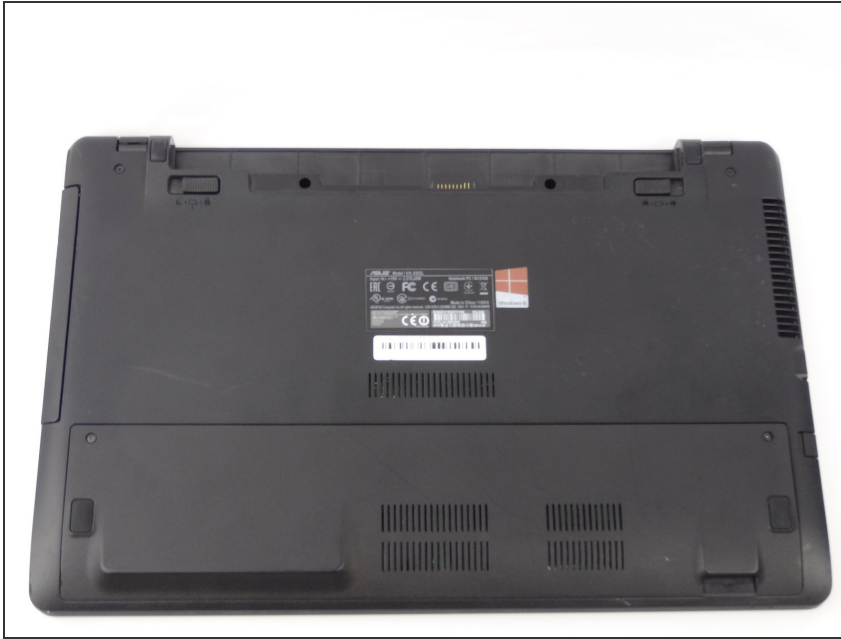
Step 1 — Battery

i Battery is not showed in pictures.

- Flip the laptop face down.

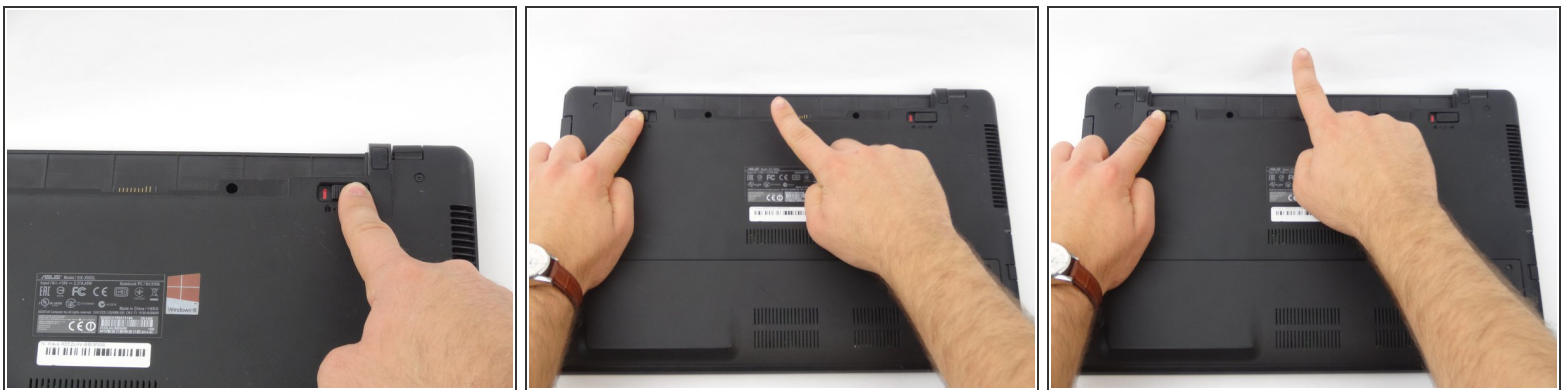
Step 2

- Slide the right button to the left.
- Hold the left button to the right.
- While you hold the left button in position, slide the battery out by pushing it away from you.

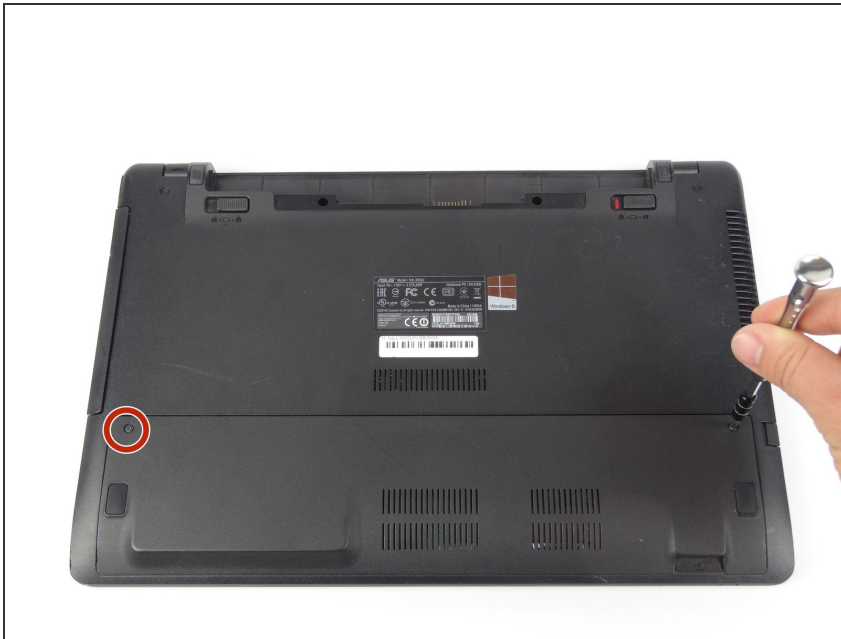
Step 3 — CD Drive

- Locate the bottom panel. It is at the opposite end of the battery.
- Remove the two 12mm screws at the bottom panel with a Tri-wing Y1 screwdriver.

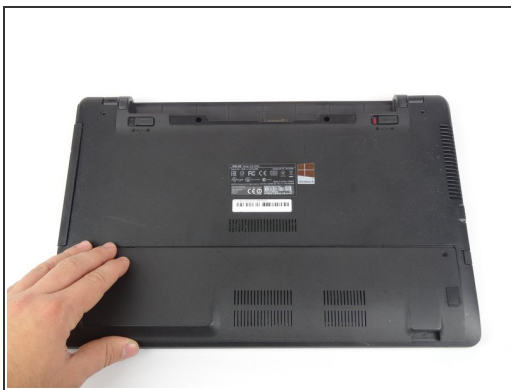
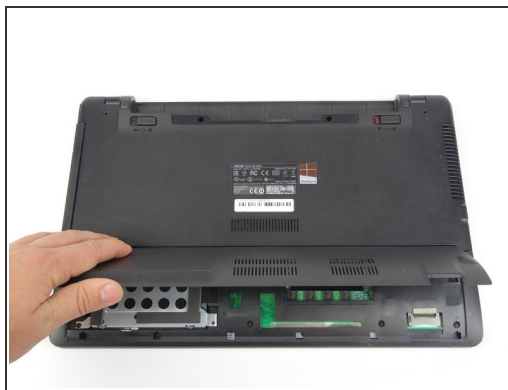
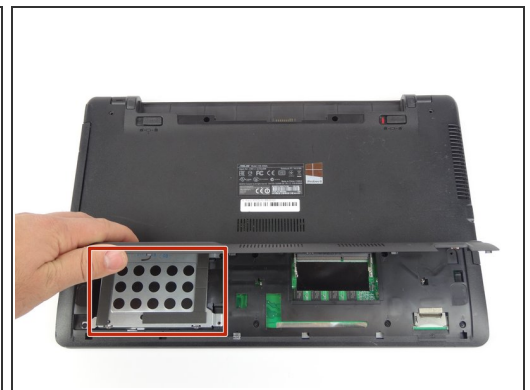
Step 4

- Remove bottom panel by lifting it up.
- Locate the hard drive.
- It is located in the bottom left corner.

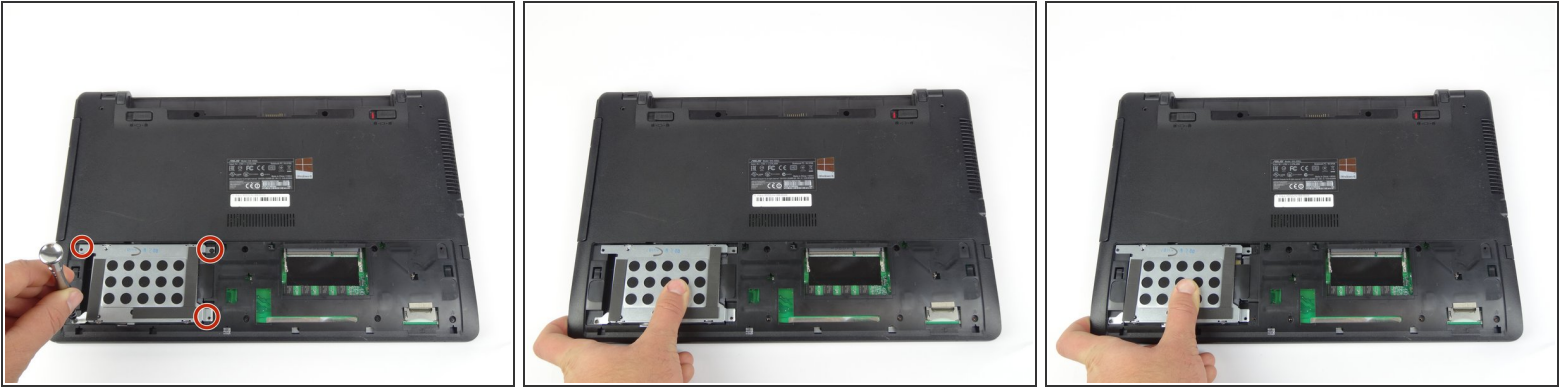
Step 5

- Remove the four 5.5mm screws located on the hard drive case using a Tri-wing Y1 screwdriver.
- Slide the hard drive out to the left.

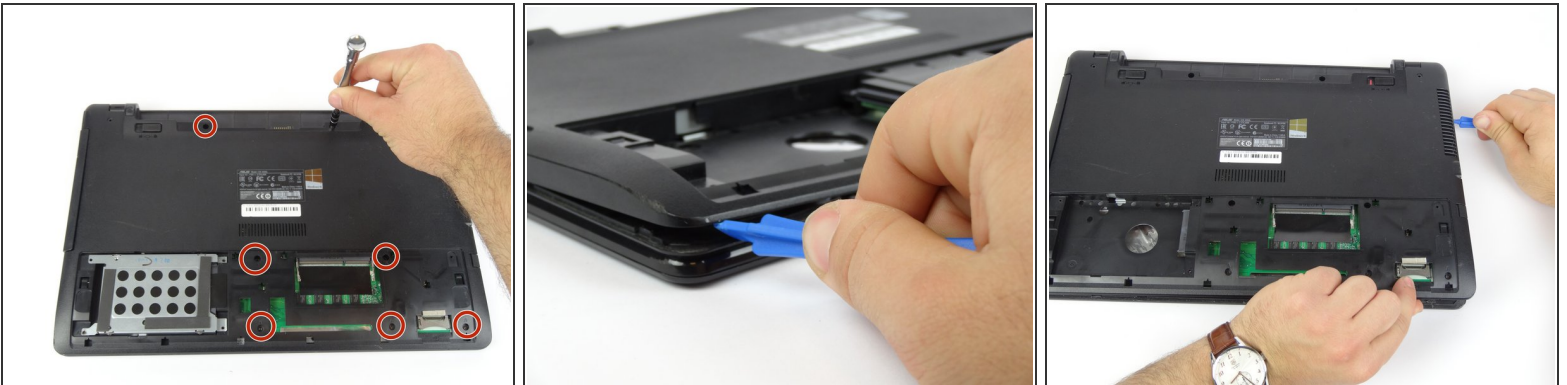
Step 6

- Use Tri-wing Y1 screwdriver to remove seven 4mm screws from battery area.
- Use opening tool to split keyboard from base of the laptop.
- Make sure to start from one end and go around the edges.

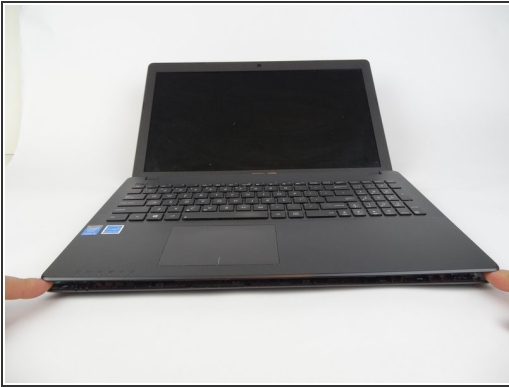
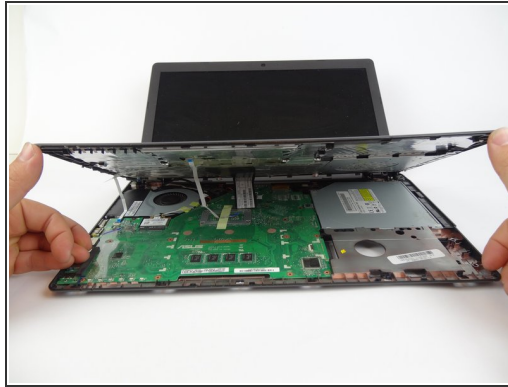
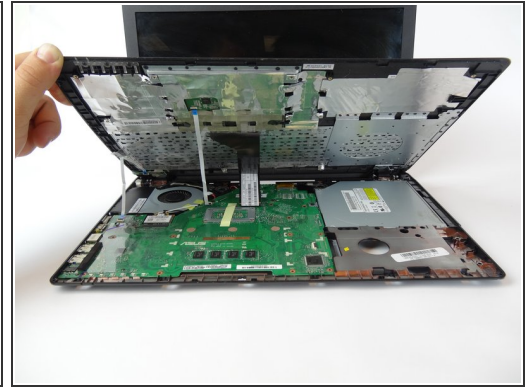
Step 7

- Flip laptop to sit on its bottom.
- Lift keyboard up by the front edge

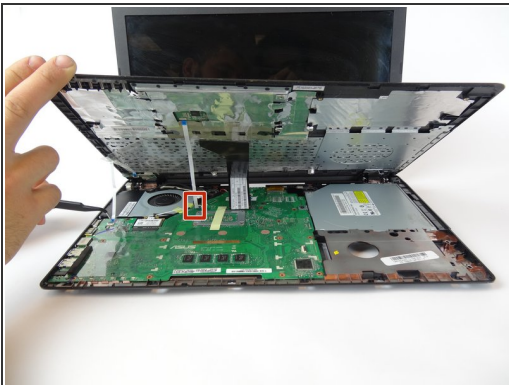
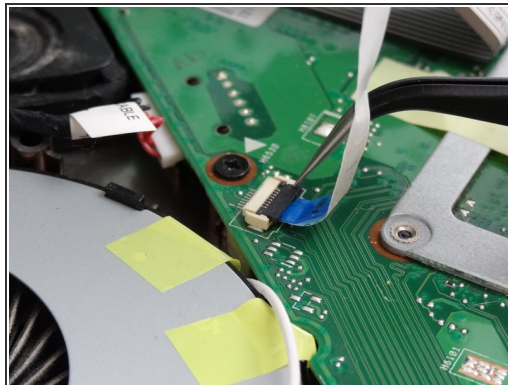
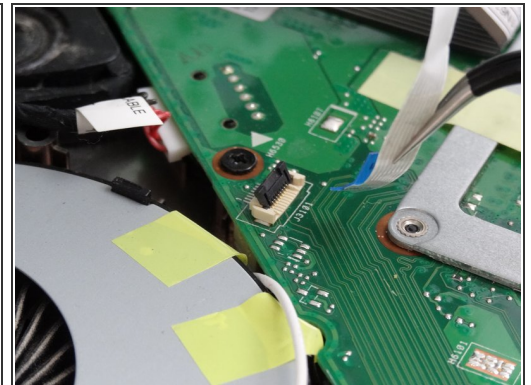
Step 8

- Flip up the small locking flap for the two ZIF connectors.
- Unplug the connectors that are keeping the keyboard connected.

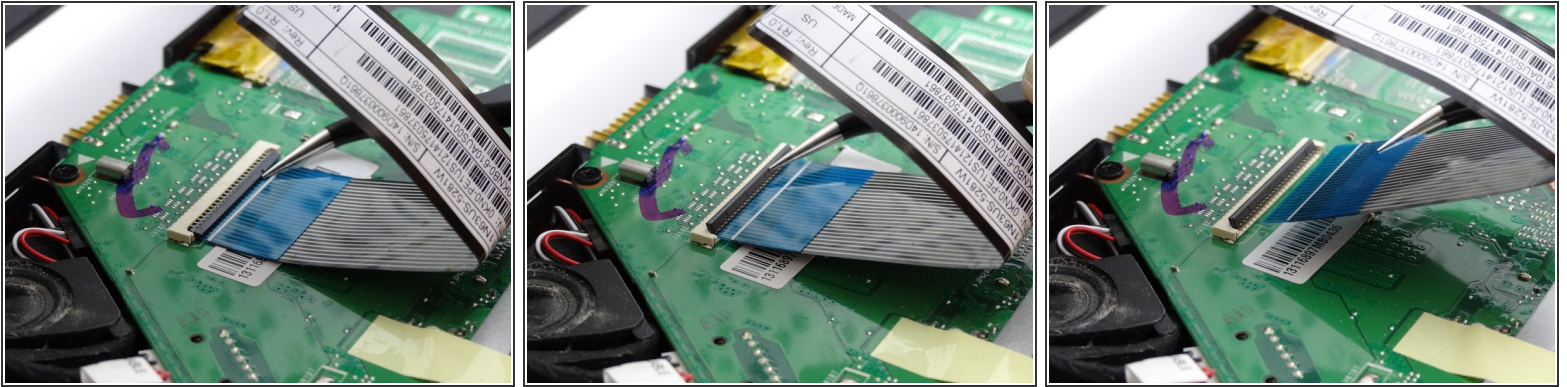
Step 9

- Flip up the locking flap for the ZIF connector.
- Unplug the connector that is keeping the keyboard connected.

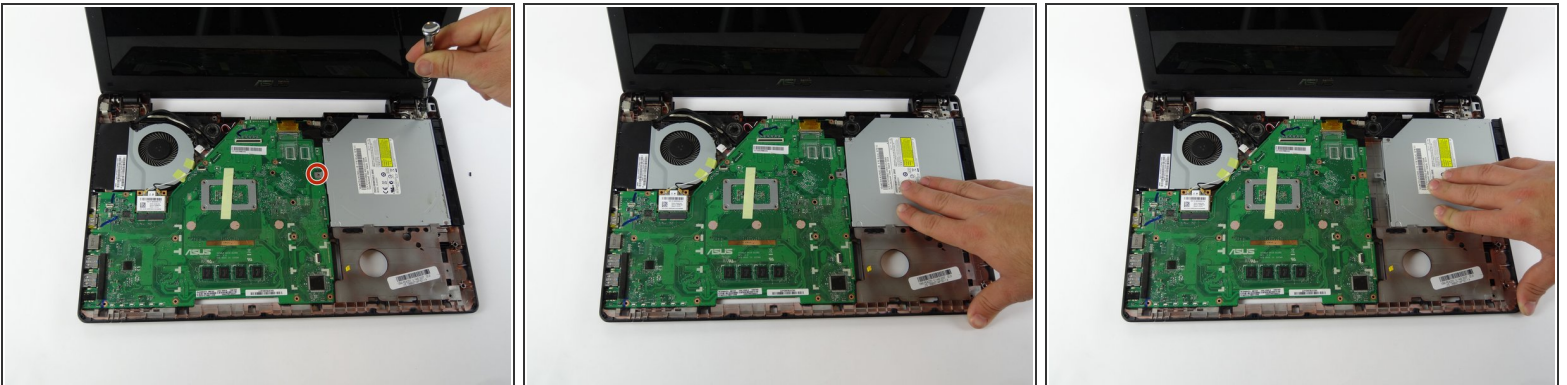
Step 10

- Remove keyboard from laptop.
- Remove two 4mm screws around CD drive
- Slide the CD drive out to the right to remove it.

To reassemble your device, follow these instructions in reverse order.
