Kenwood DNX571HD CD/DVD Drive Replacement

How to remove and replace the CD/DVD module in a Kenwood DNX571HD.

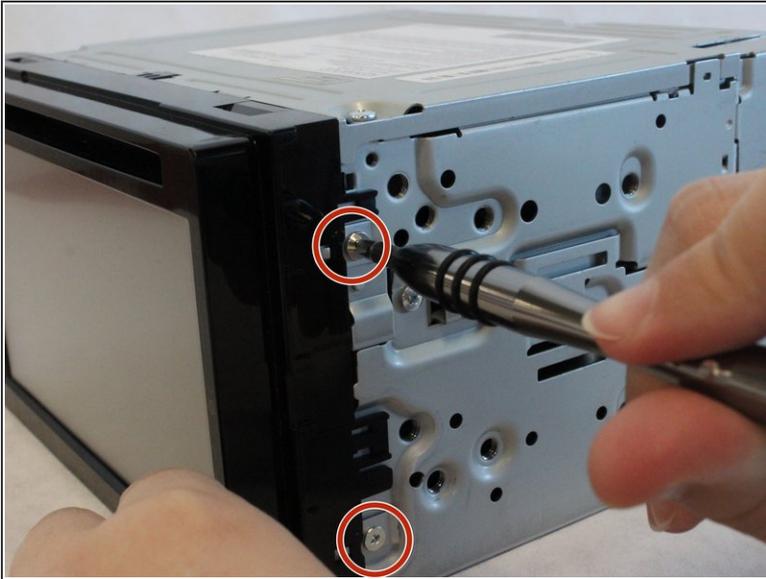
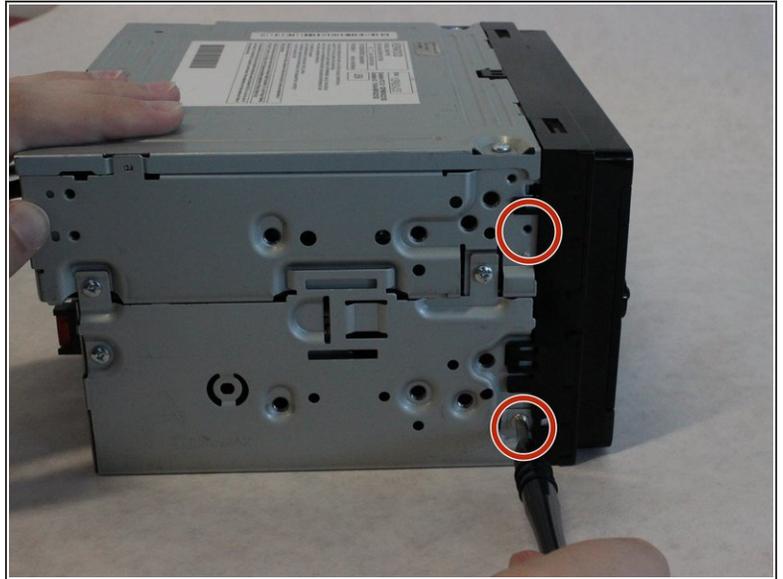
Step 1 — CD/DVD Drive

- Unscrew the four 3.5mm side screws with a Phillips #1 screwdriver.

i There are two screws per side.

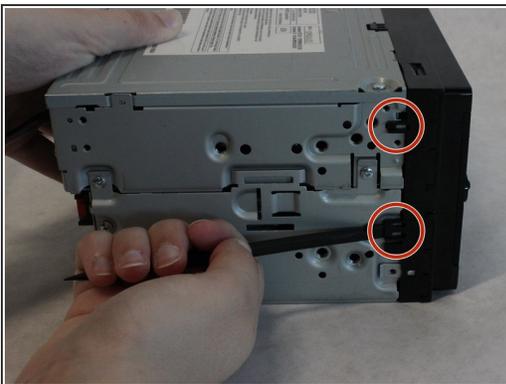
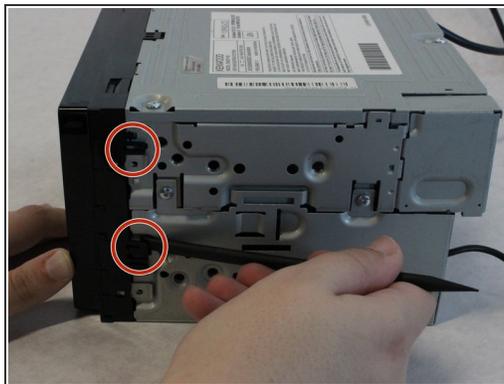
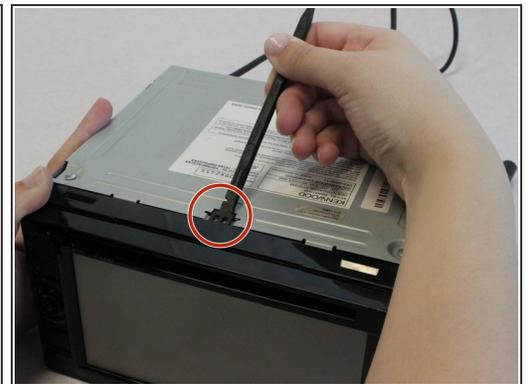
Step 2

- Use a spudger to unhook the plastic clips on the sides and top of the front panel. There are two clips on each side and one clip on the top.

i Place the spudger between the plastic tab and the metal case and gently lift the spudger away from the case.

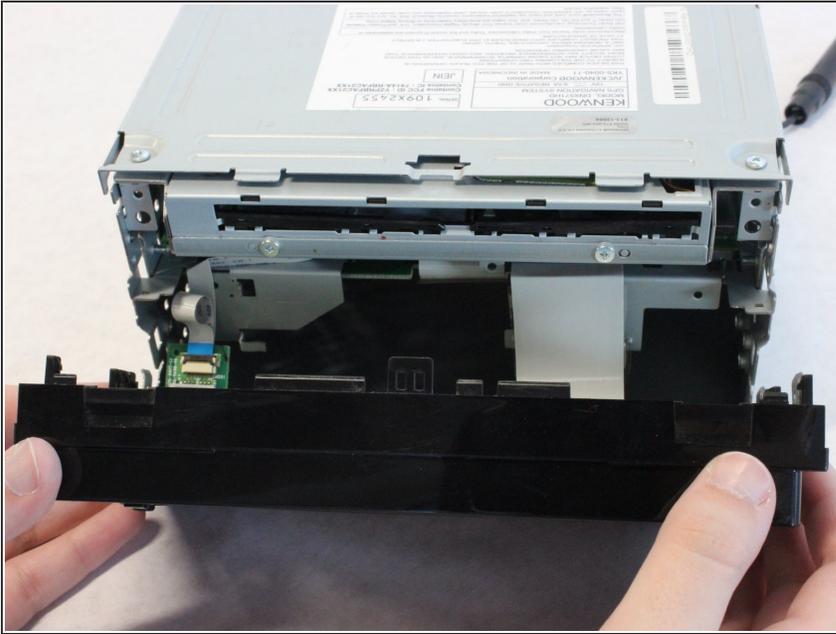
Step 3

- Pull the top of the front panel out and down to remove front panel.
- ⚠ Remove the front panel gently so as not to damage the ribbon cables behind it.

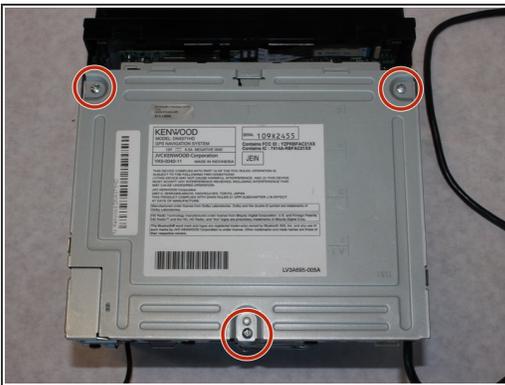
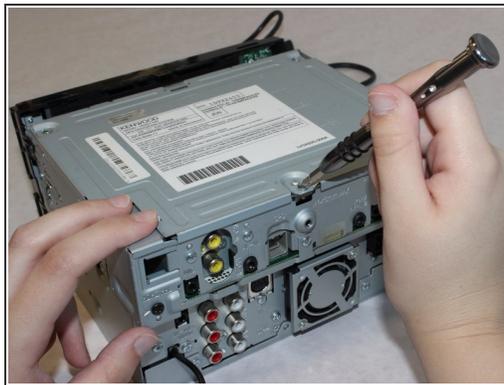
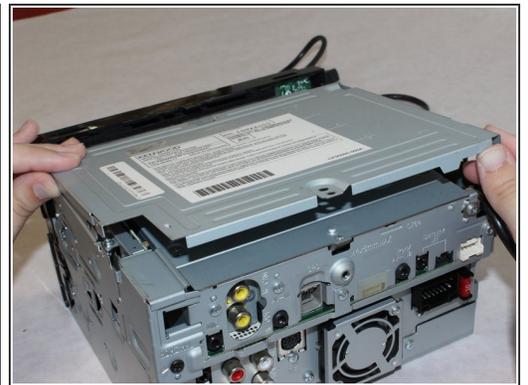
Step 4

- Unscrew the three 5mm screws from the top of the device using a Phillips #1 screwdriver.
- Lift up to remove the top casing.

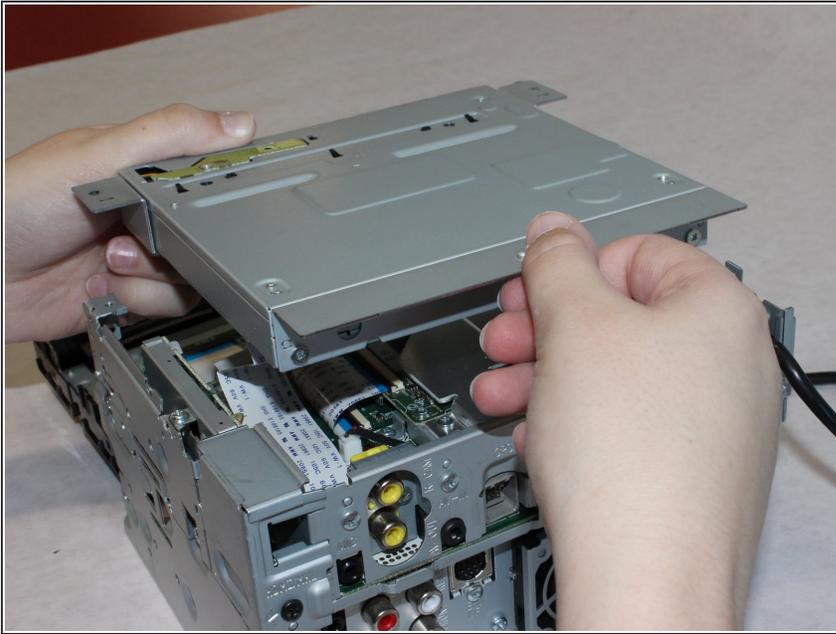
Step 5

Lift the CD drive carefully to expose the attached cable underneath.

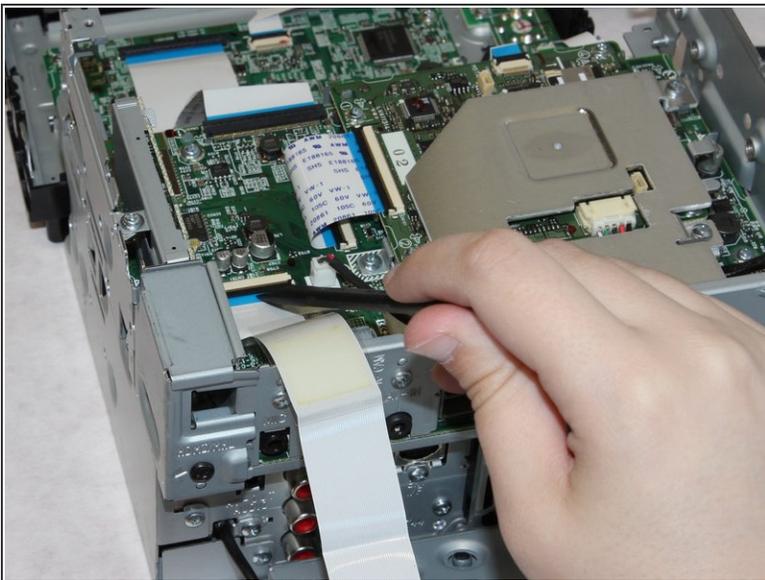
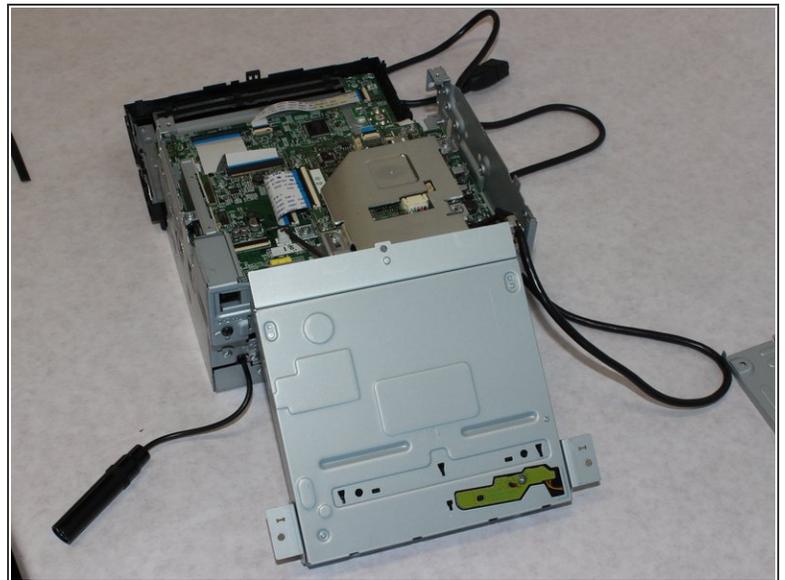
Step 6

- Flip up the black clasp with a spudger to disconnect the large white ribbon cable connecting the CD drive to the board underneath.
