Razer Naga Trinity LED Light Ribbon Cable Replacement

Written By: Alexandros Andreou

If the LED on the mouse will not illuminate, the LED light ribbon cable might be disconnected or might need to be replaced. Reasons that the LED light ribbon may be non-functional is that the mouse drive could be out of date, there could be a physical issue with the ribbon cable, or there could be a connection issue. This guide will list all required steps to properly replace the LED light ribbon cable from the Razer Naga Trinity.

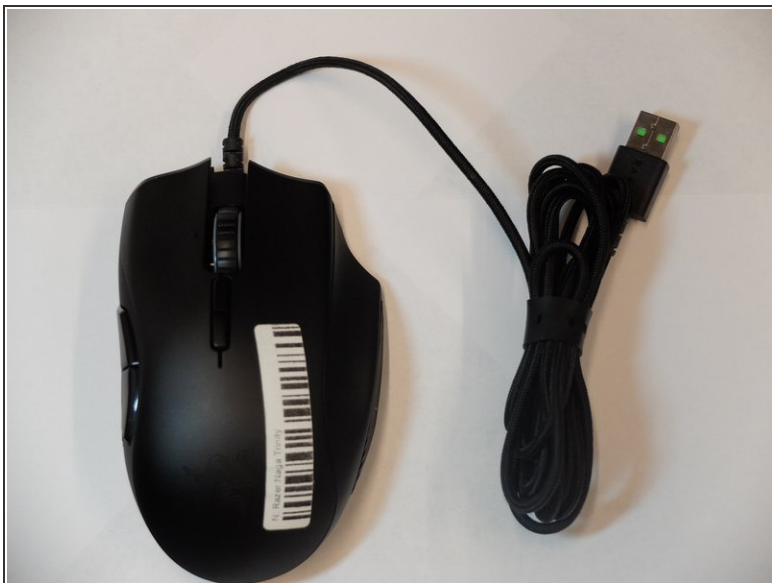
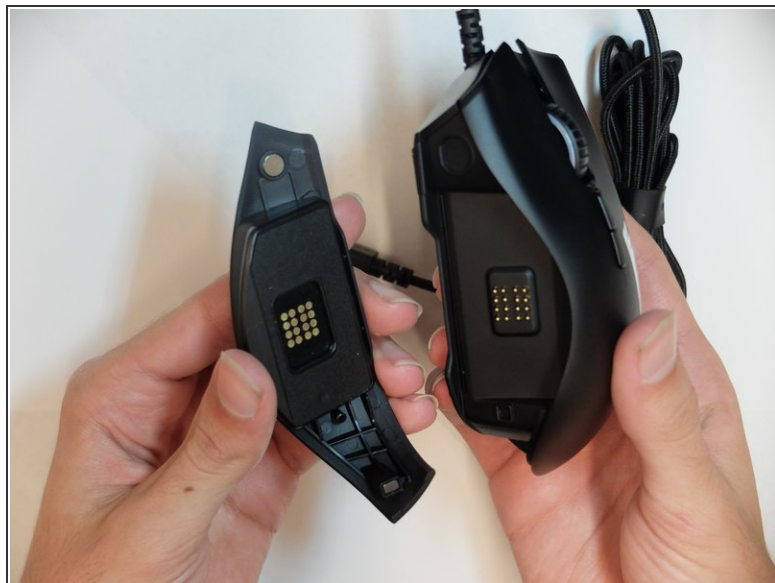
Step 1 — Razer Naga Trinity Disassembly

- Remove the interchangeable side plate.

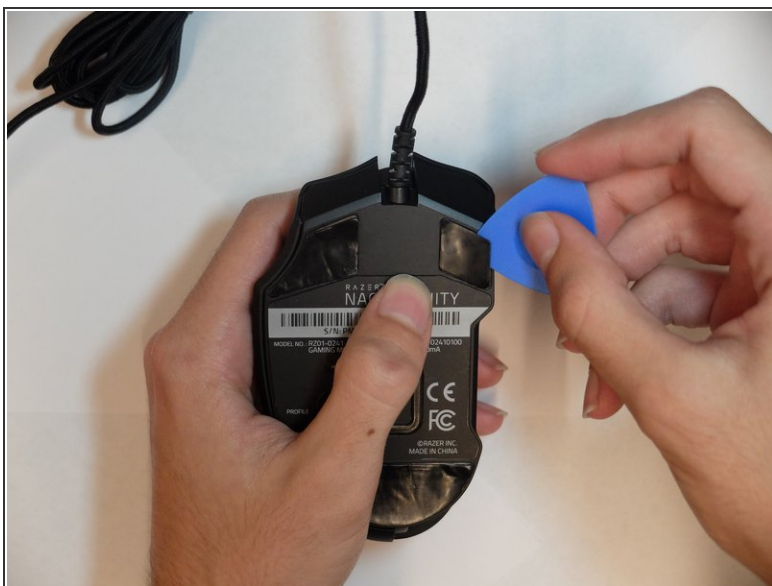
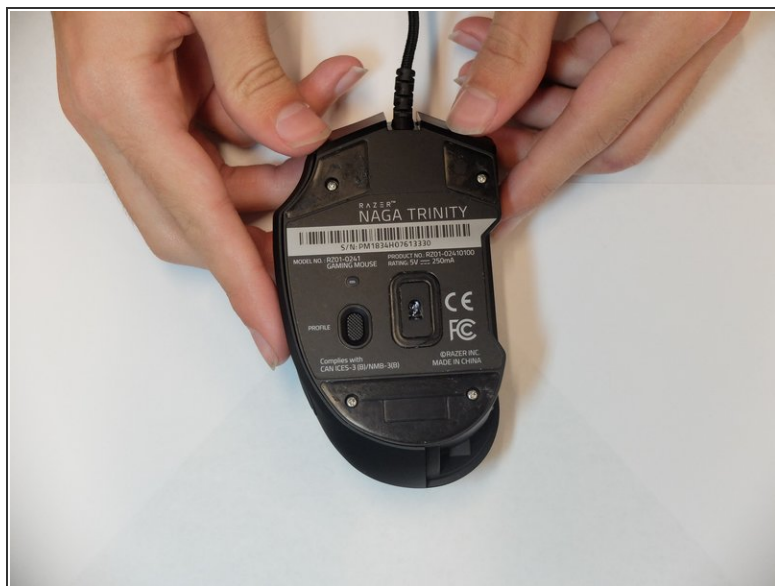
Step 2

- Remove the mouse's feet using the opening pick.

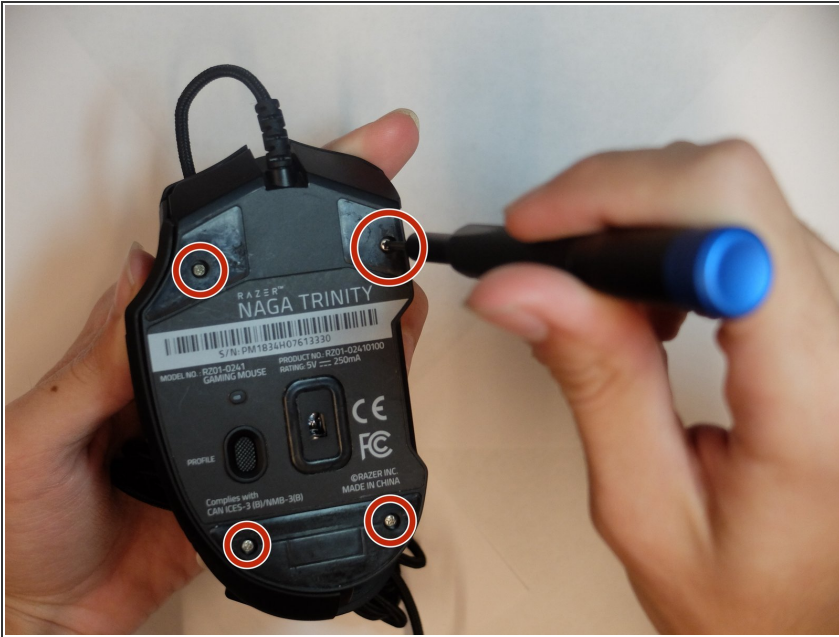
Step 3

- Remove the four 6mm screws by using a JIS #1 screwdriver.

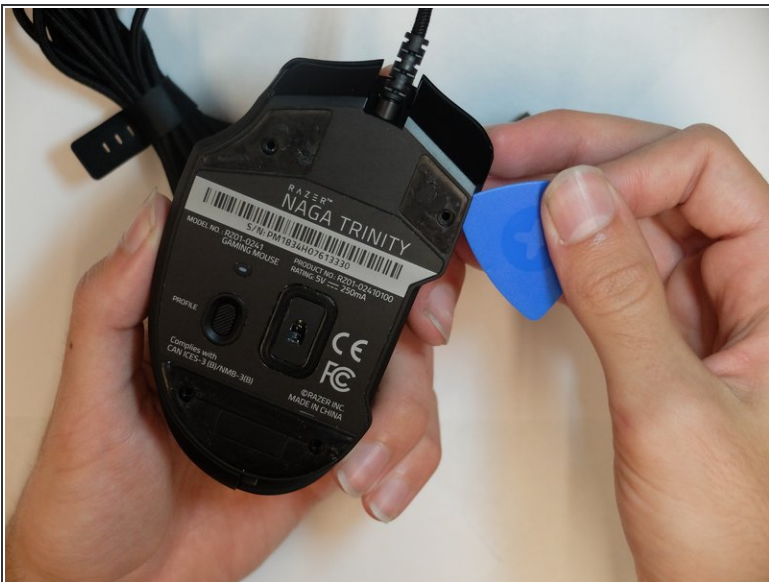
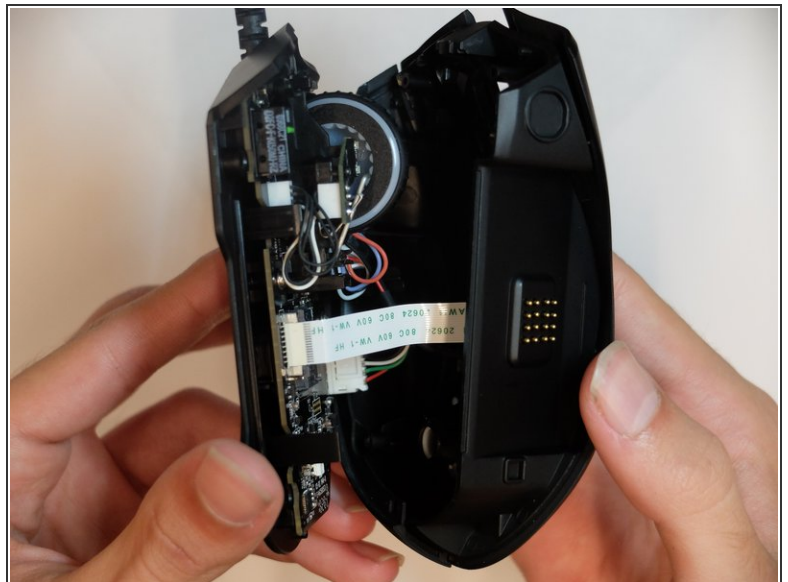
Step 4

- Separate the top mouse housing from the bottom mouse housing using the opening pick.

⚠ Be careful not to tug too hard on the ribbon connector.

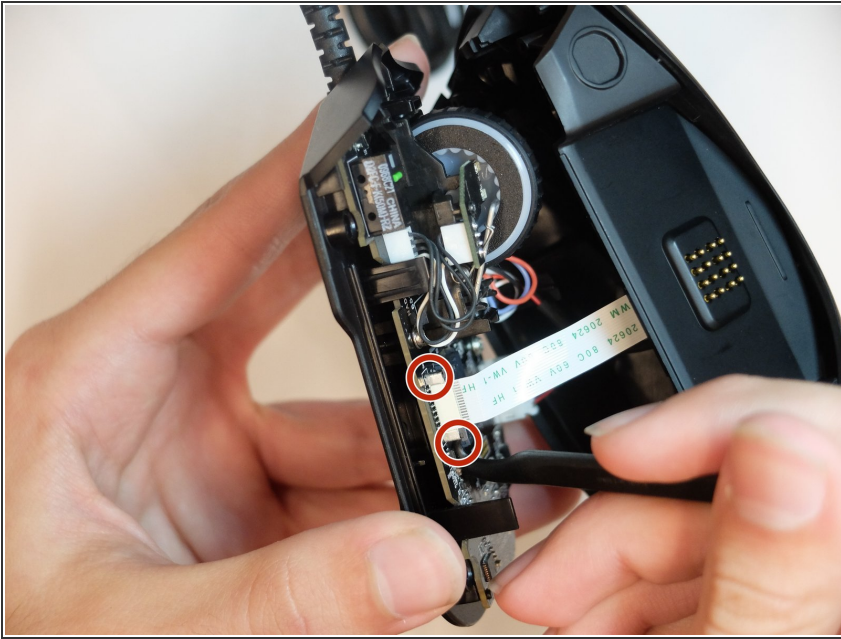
Step 5

- Unlock the ribbon connector that is held down by the main board clips using the spudger's pointed end.

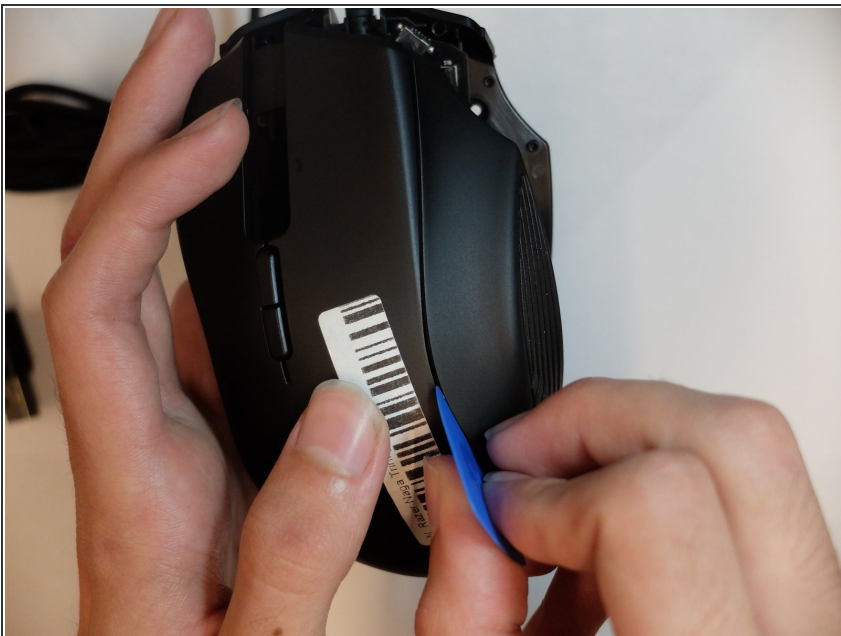
Step 6

- Remove the side housing using the opening pick.

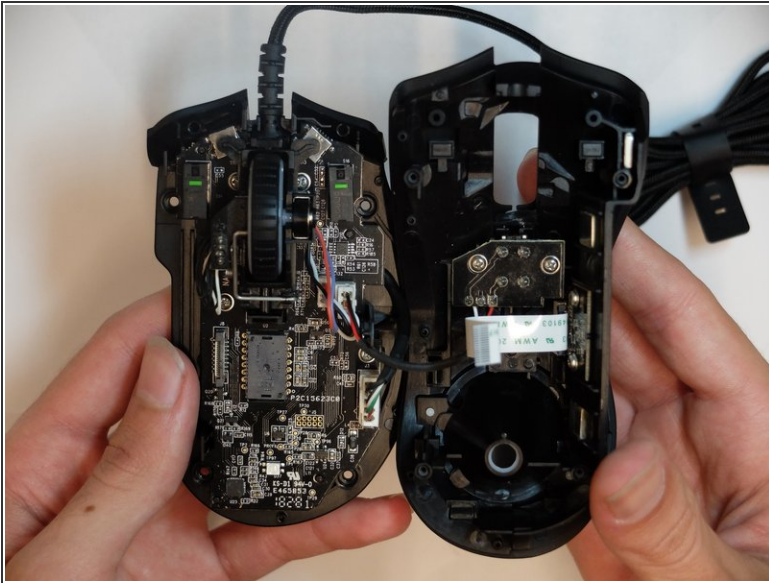
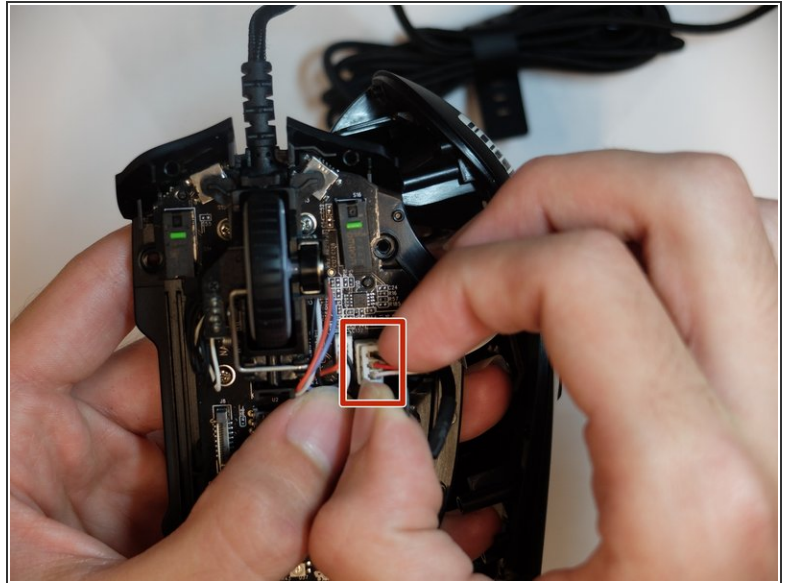
Step 7

- Remove the top housing LED 3-Pin connector that is near the main board.

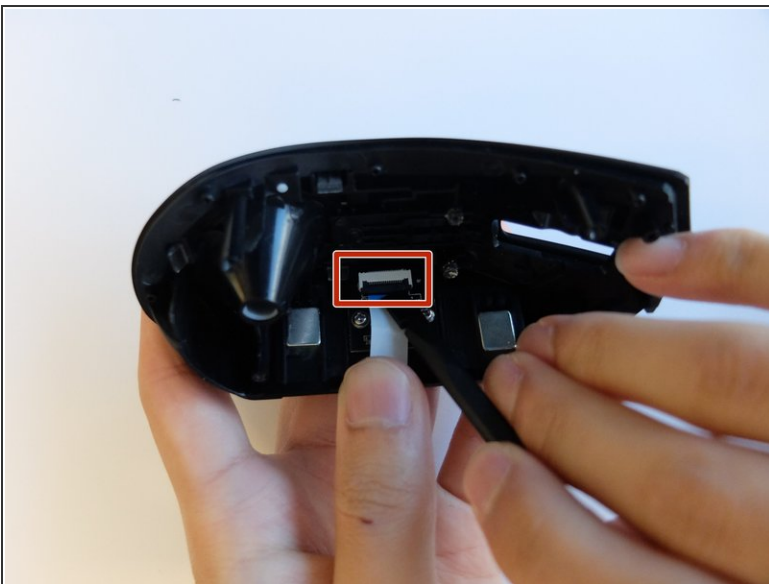
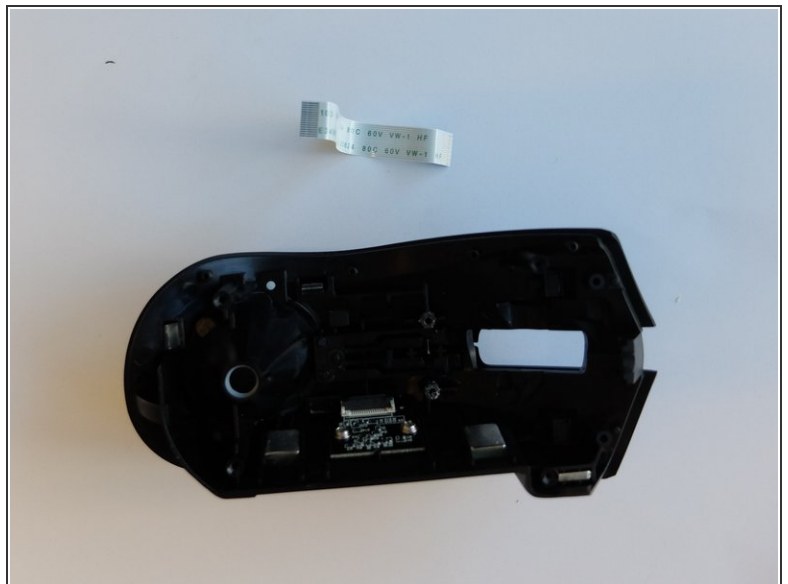
Step 8 — LED Light Ribbon Cable

- Using the flat end of a spudger, unlock the ribbon cable holding the clips.
- Remove the ribbon cable.

To reassemble your device, follow these instructions in reverse order.
