Toro Walk Behind Mowers 21199HD 2018 Left Blade Replacement

Guide to remove and replace the left blade on the Toro Walk Behind Mower 21199HD 2018.

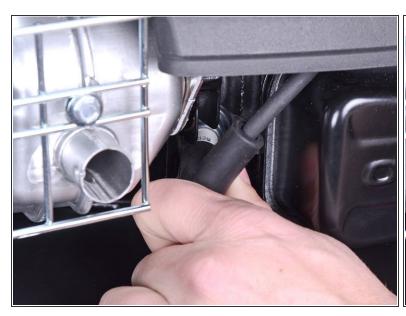
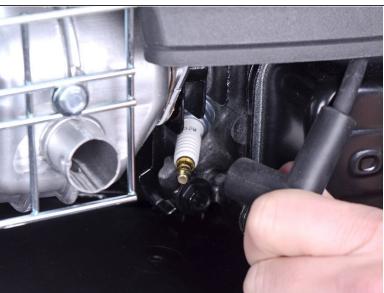
Step 1 — Disconnect the spark plug wire

- Refore you begin, ensure that the mower is powered down and cool to the touch.
- Grab the plastic housing at the end of the spark plug wire and pull firmly to disconnect it.

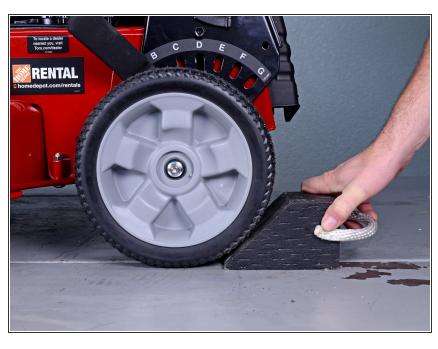
Step 2 — Chock the rear wheels

- Chock the rear wheels to prevent the mower from rolling during service.
- if the blades are extremely dirty, you can clean them using the washout fitting so the bolts on the underside of the blade guard are accessible.

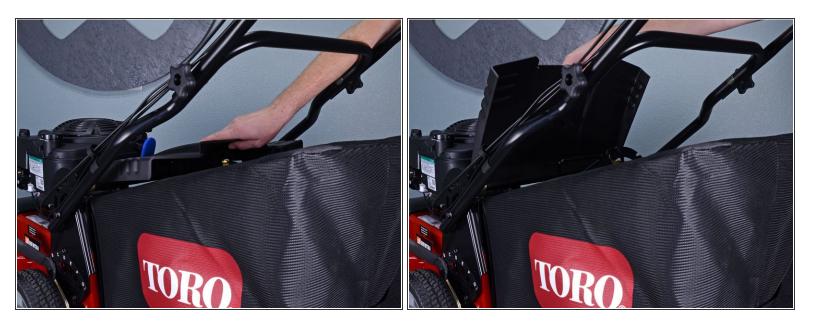
Step 3 — Lift up the deflector

Lift up the plastic deflector.

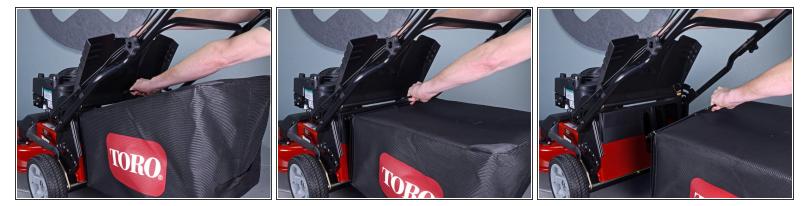
Step 4 — Remove the grass bag

- While holding the deflector up and out of the way, lift the grass bag handle away from the mower to detach it.
- Remove the grass bag.

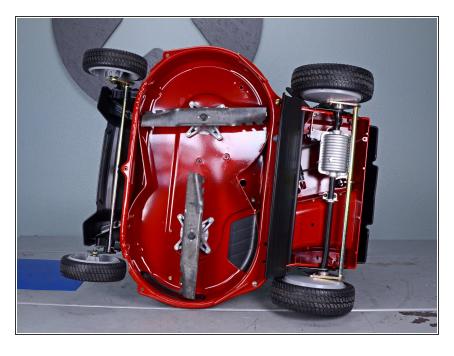
Step 5 — Tilt the mower on its side

- Tilt the mower onto its side so the blades are facing out.
 - (i) This may require two people.

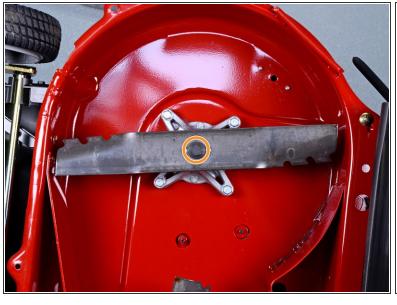
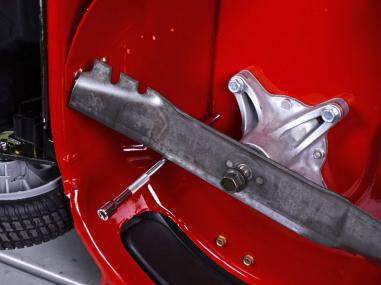
Step 6 — Remove the blade bolt

- Use an impact driver with a 5/8-inch socket to remove the left blade bolt.
 - if necessary, brace the blade with a screwdriver or extension by placing it in the hole in the metal blade guard.

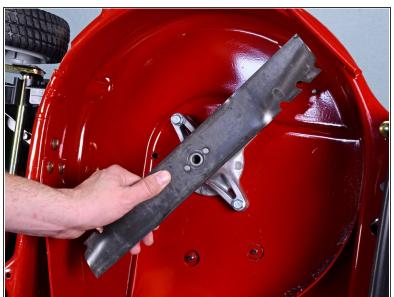
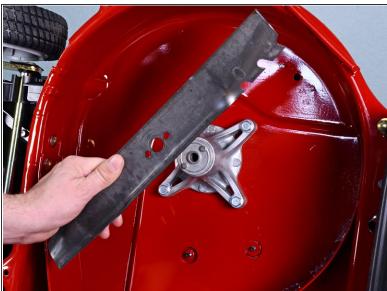
Step 7 — Remove the blade

- Remove the left blade.
- Mhen installing the new blade, ensure that it's in the correct orientation and direction.

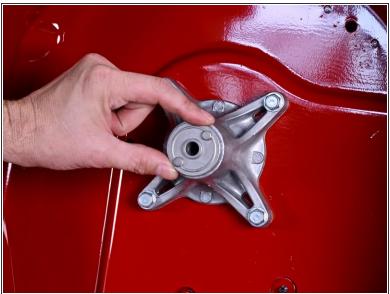
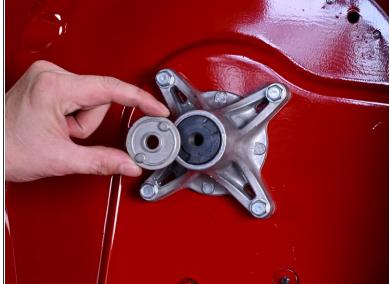
Step 8 — Remove the blade key adapter

Remove the left blade key adapter.
