# Nintendo 3DS XL Left Bumper Replacement

Written By: Jack Belcher

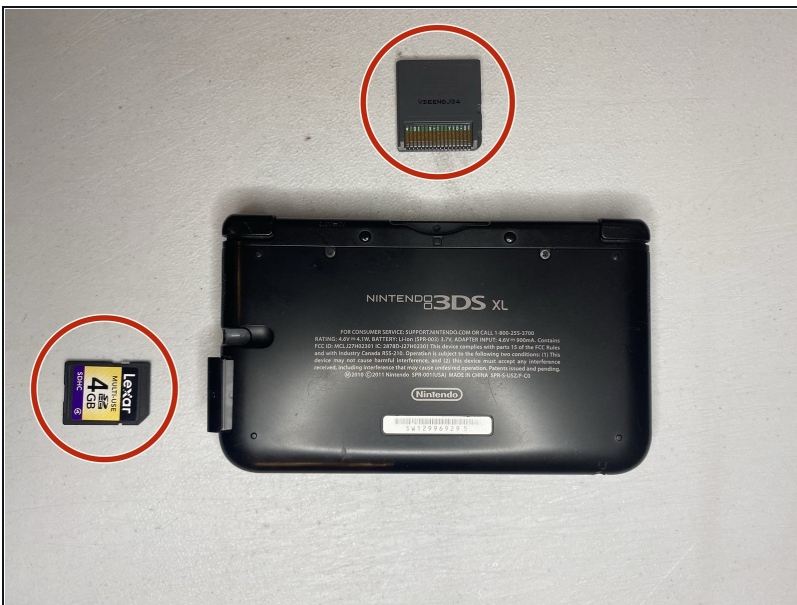
## Step 1 — Left Bumper

- Remove the SD card and the game cartridge from the device.

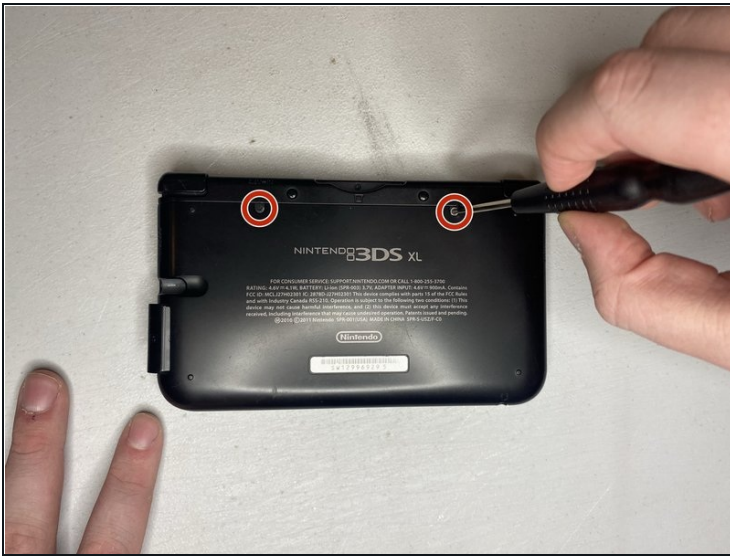
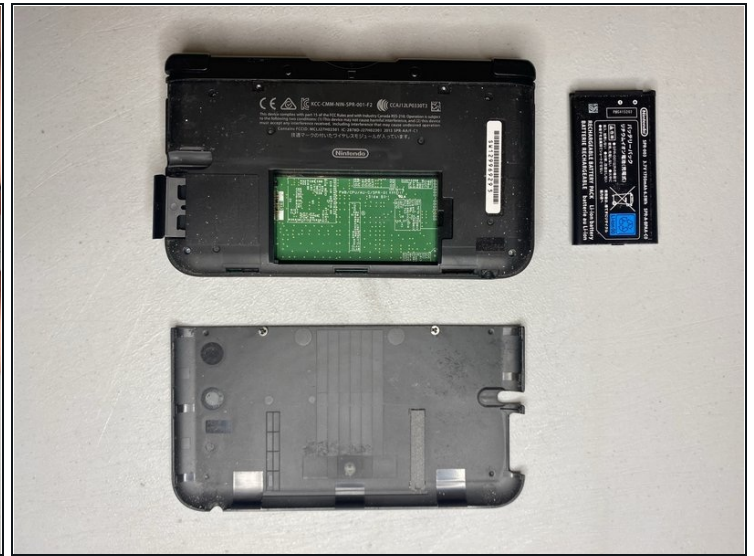
## Step 2 — Battery removal

- Locate the battery cover panel on the back of the device.
- Unscrew the two screws on the battery cover panel with a Phillips #00 screwdriver.
- Remove the battery and battery cover panel.

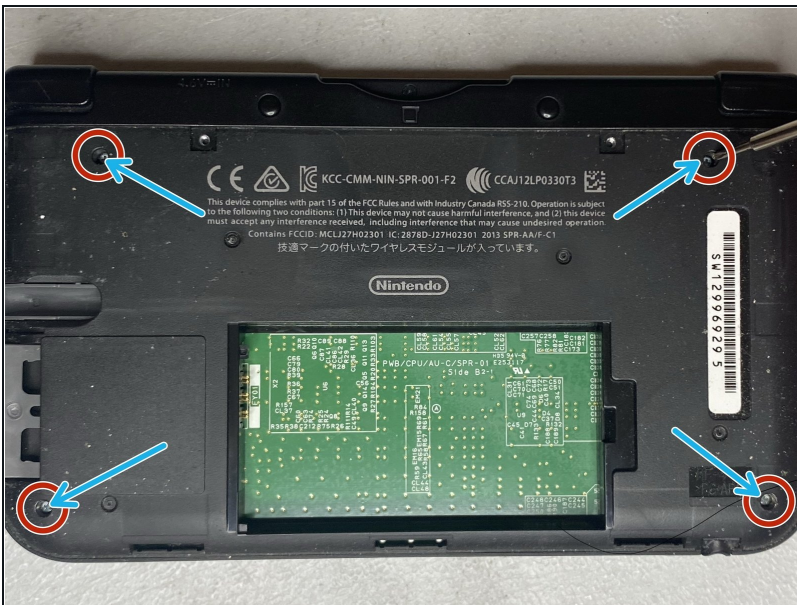
## Step 3

- Remove the four screws on the battery panel using the Phillips #00 screwdriver.

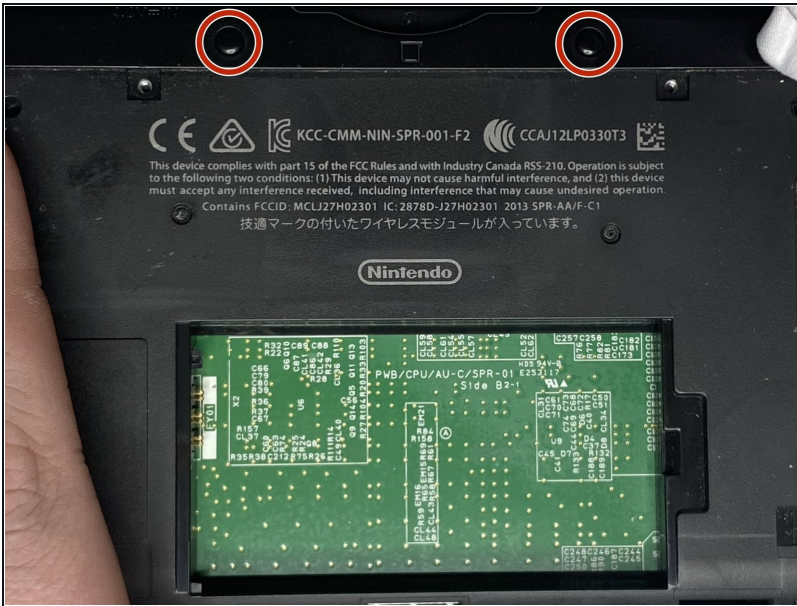
## Step 4

- Locate the two screw covers on the bottom of the back panel, near the middle of the device.
- ① These sticker-like covers are small, round, and made of rubber or plastic.
- Insert the tip of a flathead screwdriver or spudger and gently pry the cover off by applying upward pressure.
- ① You may need to wiggle the tool back and forth a bit to loosen the two covers.
- Remove the two screws located behind the screw covers using a Phillips #00 screwdriver.

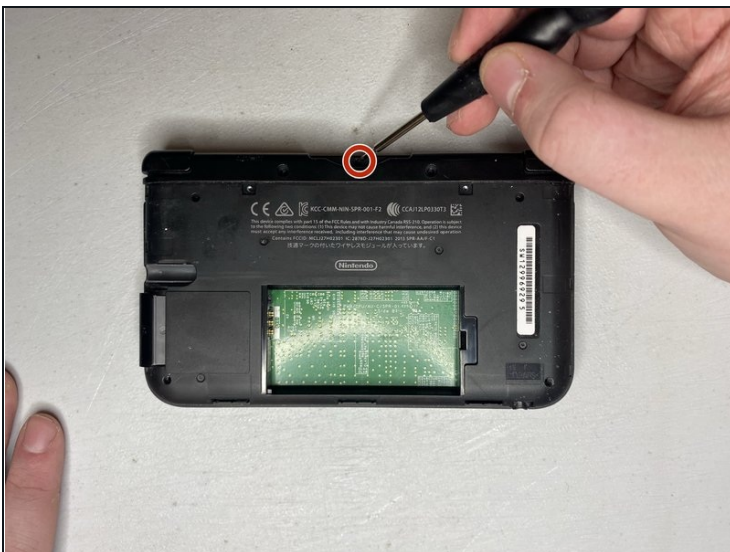
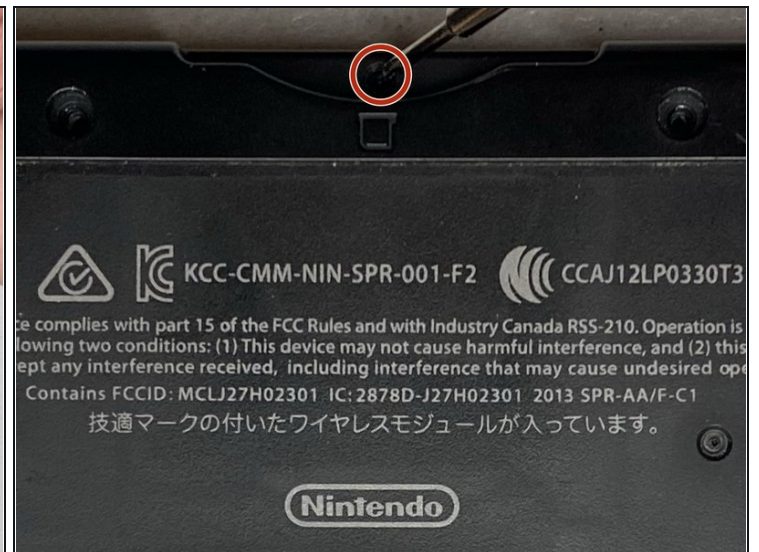
## Step 5

- Remove the screw near the game card compartment using a Phillips #00 screwdriver.

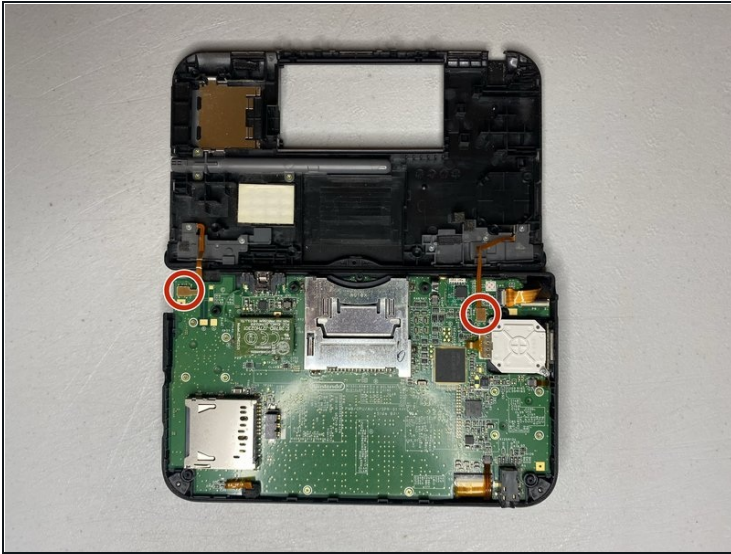
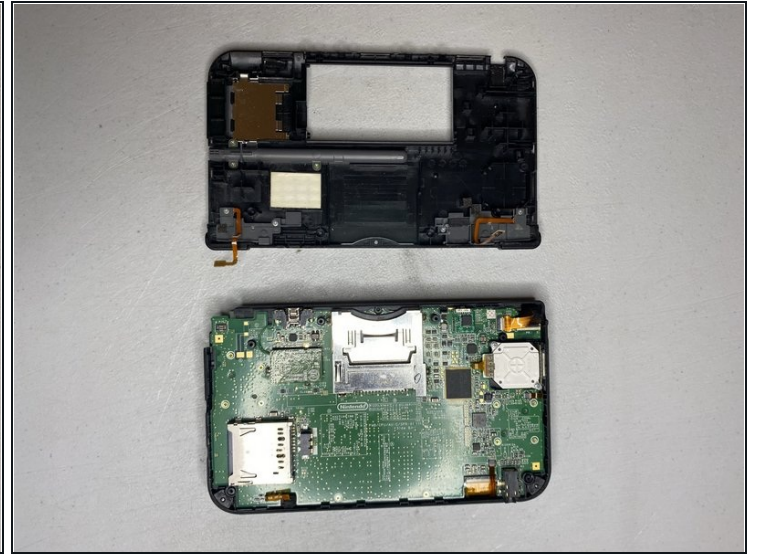
## Step 6

- Lift the back panel off of the device.

⚠ Be cautious not to pull any ribbons or cables from the motherboard as you remove the back panel.

- Locate and disconnect the ribbon cables from the motherboard by gently pulling on the tabs that hold them in place.

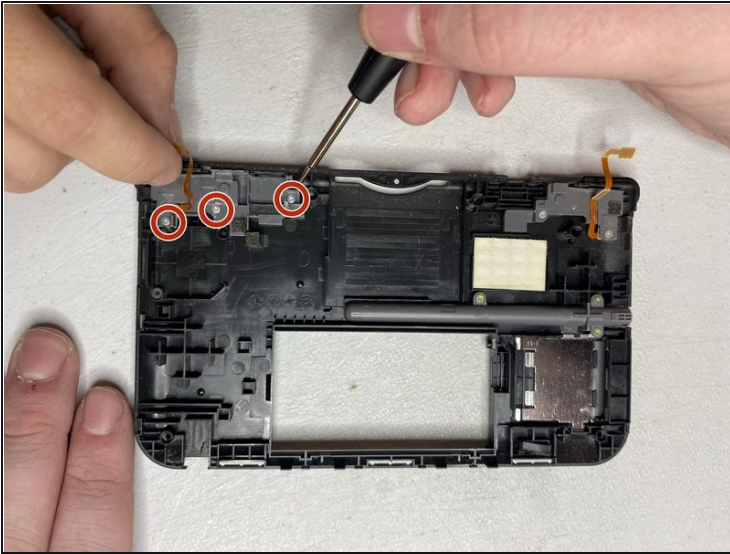
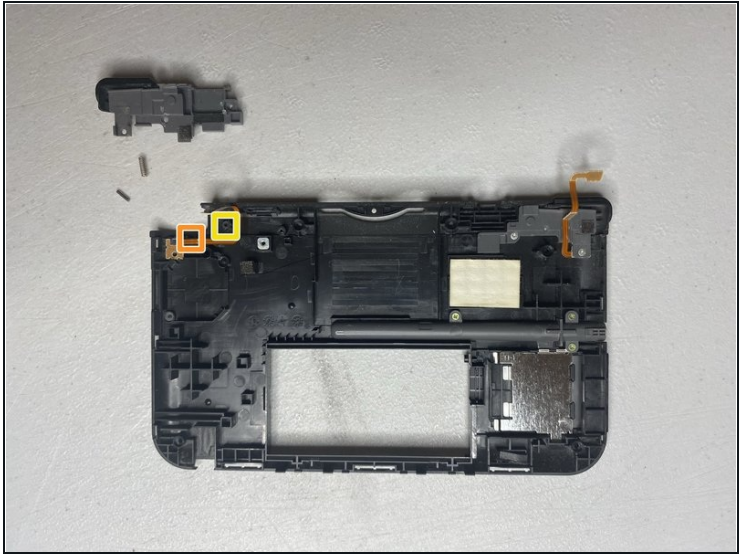
## Step 7

- Remove the three left bumper assembly screws using Phillips #00 screwdriver.
- Once the three screws are removed, gently remove the left bumper assembly from the device.
  - ⓘ The spring may eject from the assembly as you remove it.
- Remove the hinge pin from the bumper assembly.

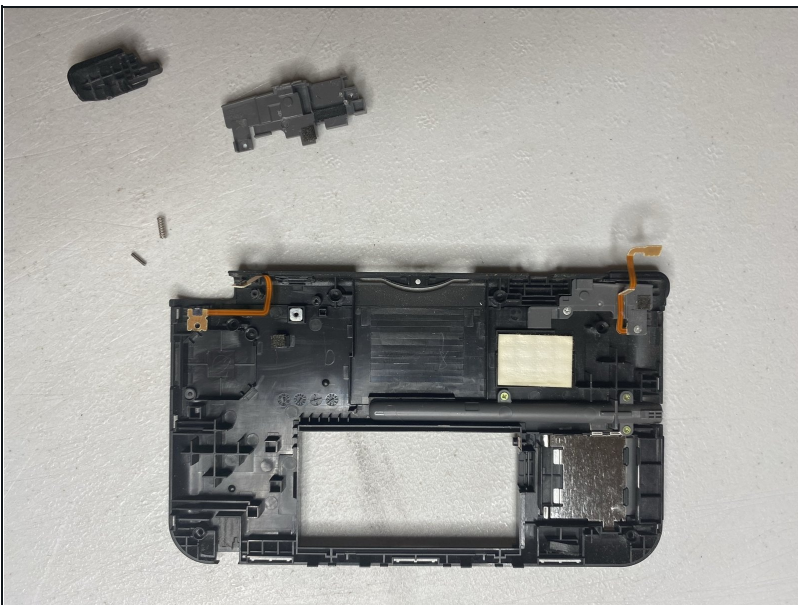
## Step 8

- Separate the bumper from the bumper assembly

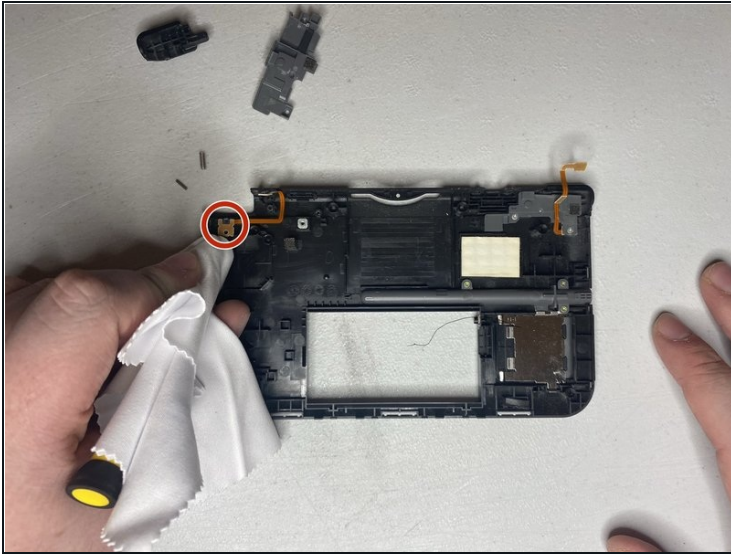
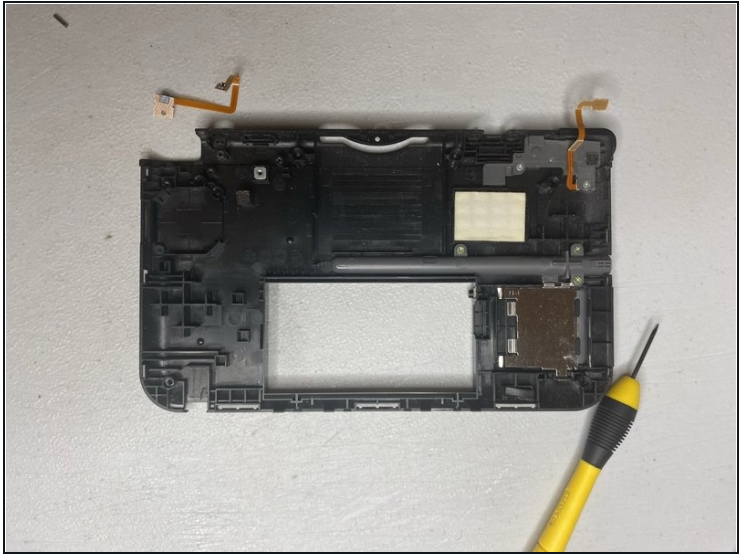
## Step 9

- Using a spudger or a flathead screwdriver, gently pull the ribbon cable straight out of the connector in order to remove it.
- ⓘ The ribbon cable can be removed by other means such as using gloves or a [microfiber cloth](#) if preferred.
- Replace the left bumper ribbon cable.
