Repairing Black and Decker - TS221 Ranger CD2000 Battery

Just like my other "high mileage" cordless screw driver, this Black & Decker model also stopped holding a charge. Here I will show how to build and replace the battery due to the unavailability of an original battery.

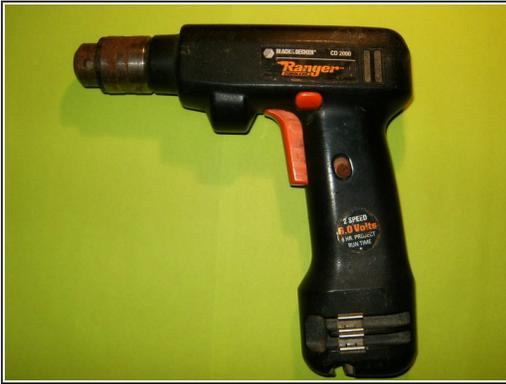
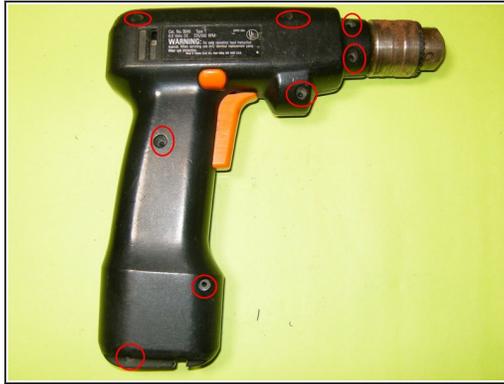
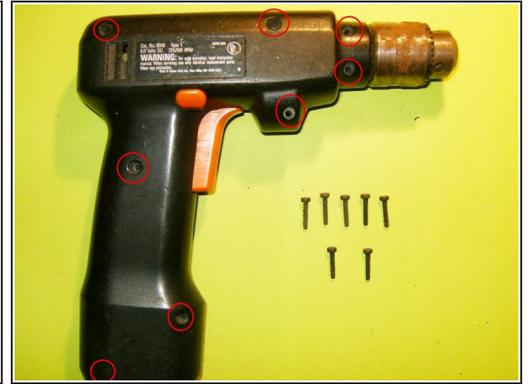
Step 1 — Repairing Black and Decker - TS221 Ranger CD2000 Battery

- Here is my 2 speed TS221 Ranger CD2000 that does no longer hold a charge.
- Removed the 8 Phillips screws from the case.
- All screws are 3/4inch long and therefore the location of the screws does not have to be marked.

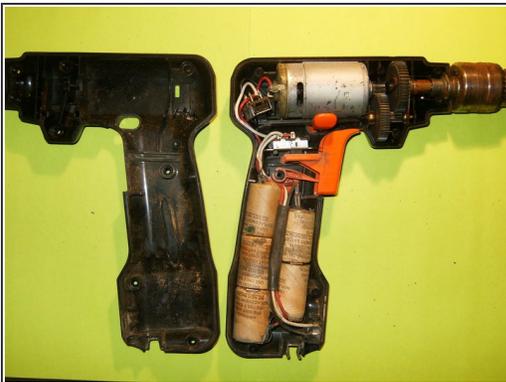
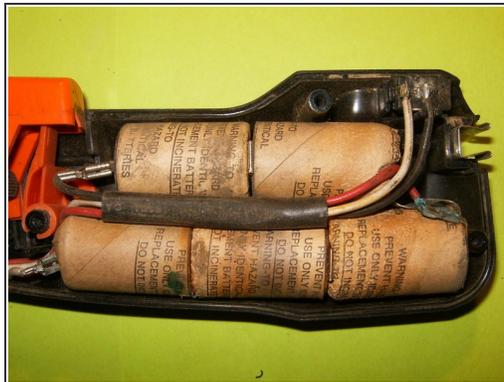
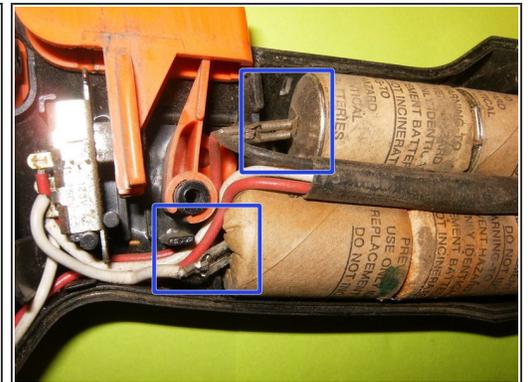
Step 2

- Separate the case.
- Here is the old battery pack
- Disconnect the battery cables

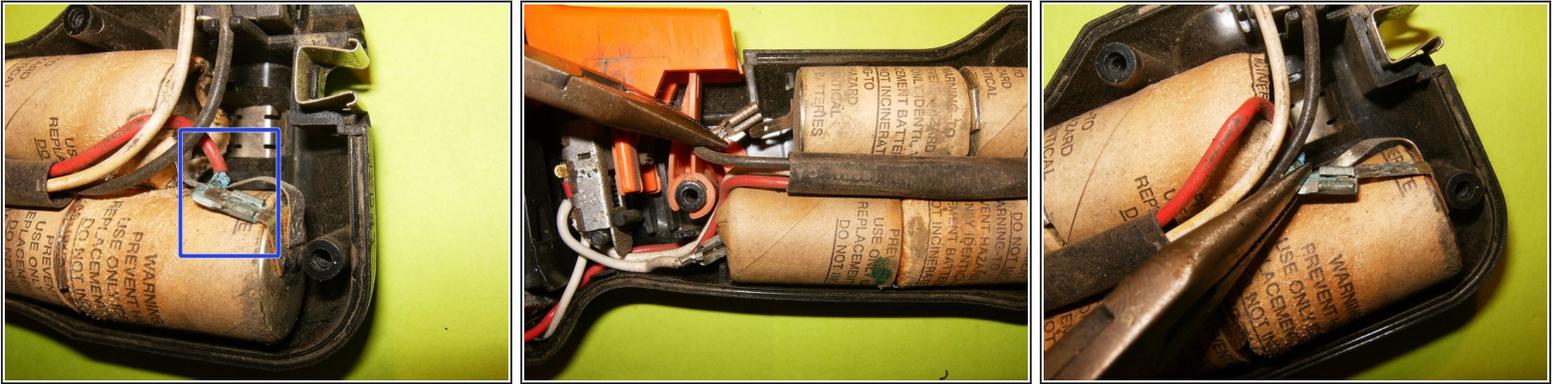
Step 3

- Disconnect the battery cable on the bottom of the pack.
- It is easier to remove the top,
- and bottom cable with a pair of needle nose pliers.

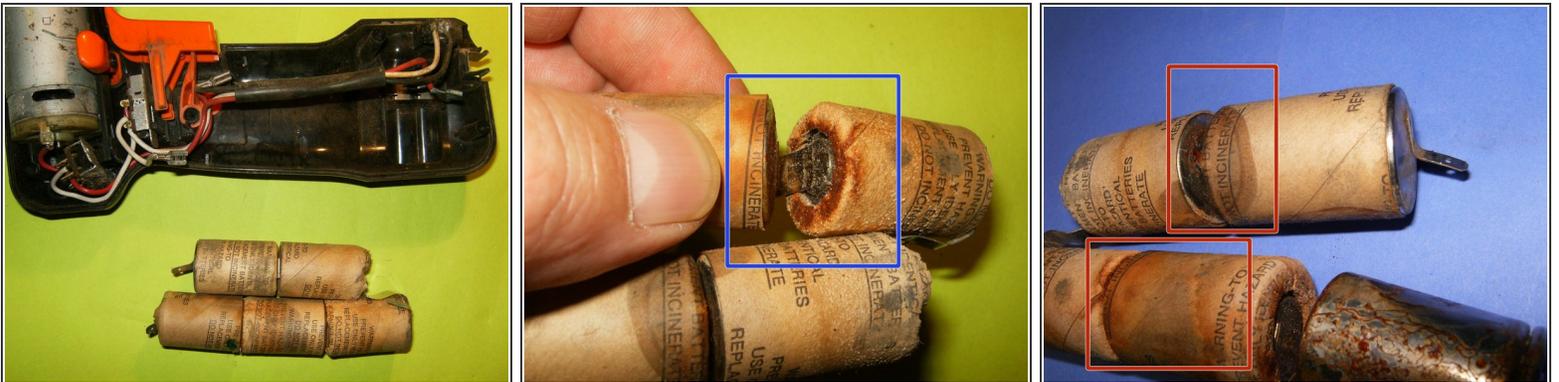
Step 4

- Remove the battery pack
- Heavy corrosion can be found on all battery tabs,
- as well as some sort of liquid damage.

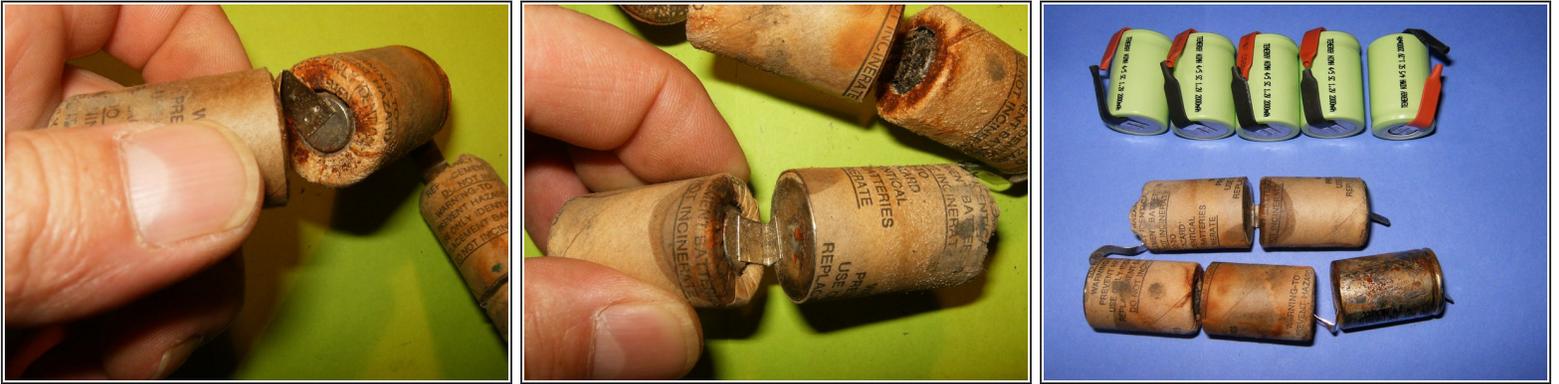
Step 5

- The battery tabs or spot welded to the batteries.
- They are in series, meaning they connect from the positive post of one battery to the negative of the next.
- Here are the 5 replacement batteries. They are 4/5sub C batteries. This means they are 80% the size of a C battery. 1.3" (33.4mm) in length by 0.9" (23mm) in diameter. 5x1.2V in series gives 6V x 2000mah
