# Mercedes W123 Glow Plug Fuse and Fuse Box, Early Style Replacement

On the diesel W123 cars there is a glow plug fuse that may break and need replacement. In addition there is a fuse box on the early style cars that may deteriorate from excess heat and need replacement. Learn how with this guide.

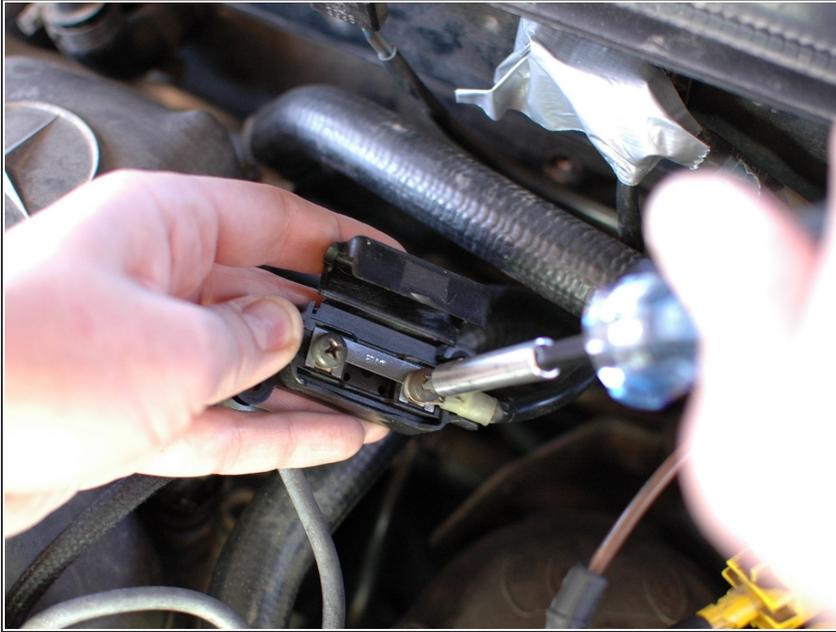
## Step 1 — Glow Plug Fuse and Fuse Box, Early Style

- The fuse box on early W123 cars, those with the glow plug relay inside the car and under the dash, usually 1980 and earlier, are located on the firewall back behind several of the soft rubber heater hoses. The location makes it difficult to photograph the fuse box when installed.
- To uninstall the fuse box simply locate it on the firewall and remove the two Phillips head screws that hold it to the firewall. These are the Phillips screws located on the upper right and lower left corners of the fuse box, outside of the fuse box cover.
- Once the fuse box is removed from the firewall it can be gently pulled forward for easier access to the screws holding the wires and fuse in place inside the box. As shown, once you've pulled the box out from under the coolant hoses you can remove the two remaining Phillips head screws and then remove the fuse box and old fuse.

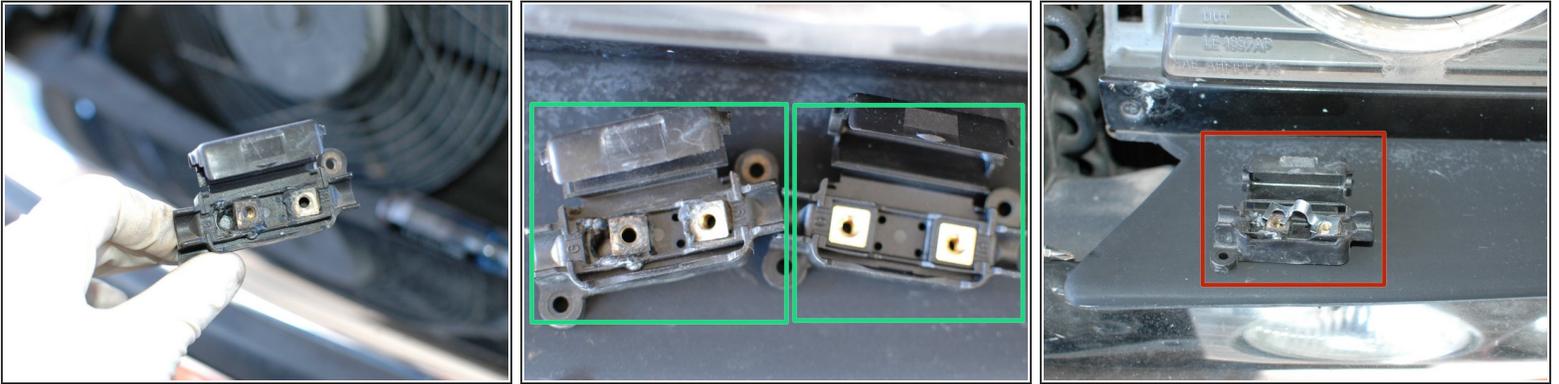
## Step 2

- With the fuse box removed it and the fuse can be inspected. This fuse box was removed because excess heat caused the fuse box plastic to melt. This allowed the copper fuse connection on the left to be pulled to the right within the body of the fuse box. Eventually the two copper sections would touch, bypassing the fuse.
- The old, damage box is shown on the left while the replacement box is shown on the right.
- See how the fuse is bent in the middle as it's left-side connection was pulled to the right.
- In this case this was caused by the timer on the glow plug relay no longer functioning after the glow system on the older style glow plug system after it was converted to the fast glow plug system. The glow plugs stayed hot, with 12V going through the fuse, while testing the window regulators on this car.
