Hisense Sero 8 Charging Port Replacement

This guide demonstrates how to replace the charging port in the Hisense Sero 8.

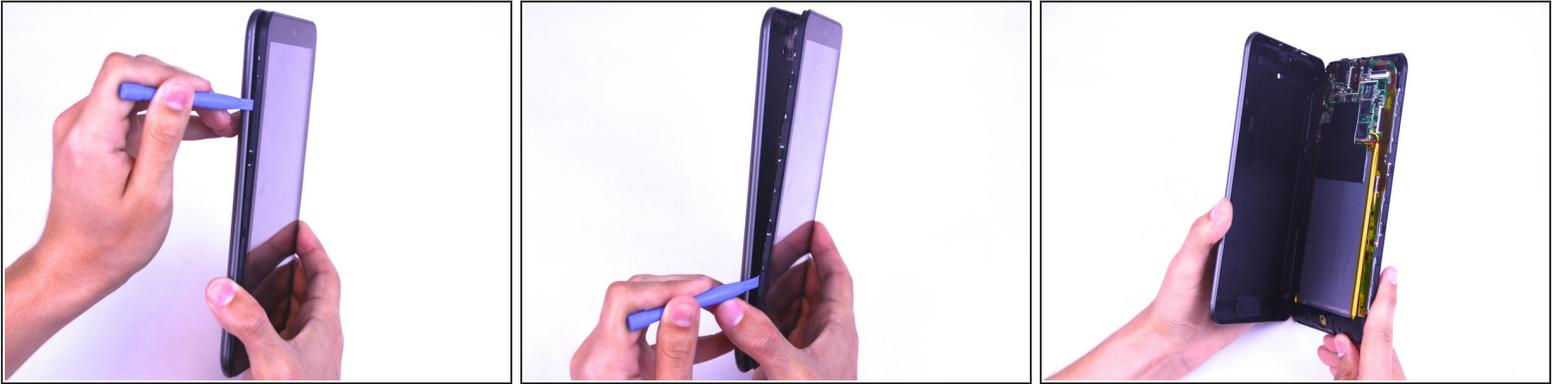
Step 1 — Charging Port

- Remove the back cover of the device using a combination of both plastic opening tools.
- Use your plastic opening tool pry open a corner of the device, then continue down the side of the device with the tool to completely open the device.

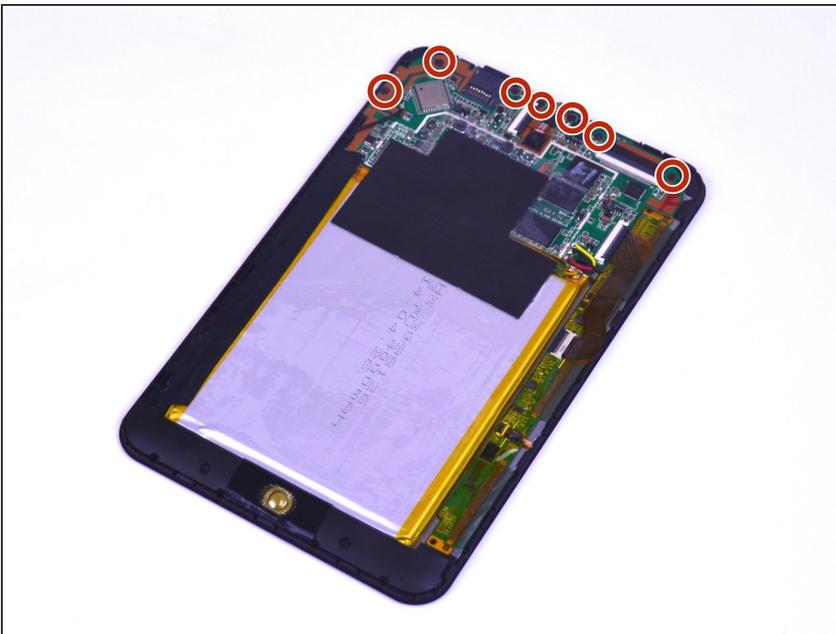
Step 2

- Remove seven of the 4.43mm screws using the Philips #00 screwdriver.
- ⓘ It is not necessary to remove the bottom two 4.43mm screws that keep the speakers in place.
