iPod Nano 5th Generation Teardown

Written By: Walter Galan

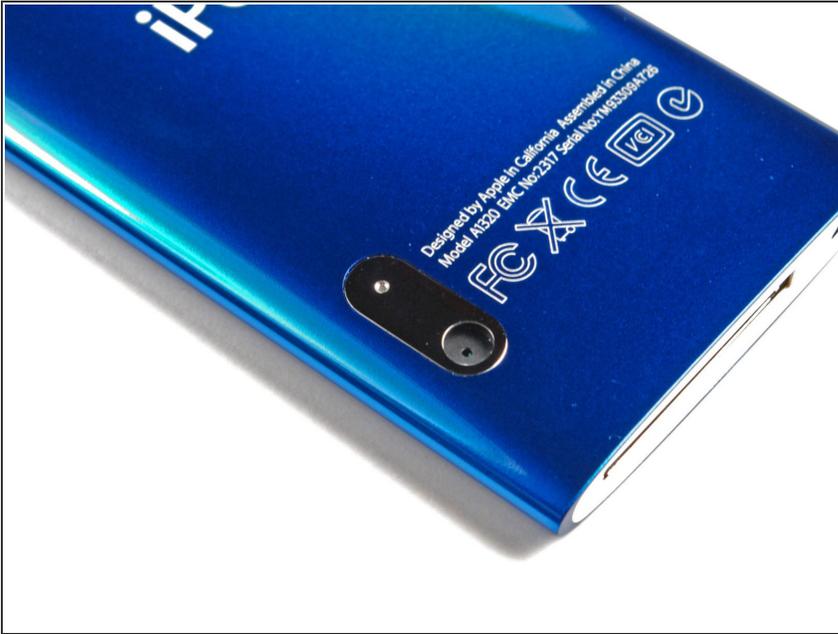
Step 3

- A video camera finally comes to the iPod line. Surprisingly, it's in the nano, and not the touch.
- According to Apple, the video camera offers:
 - H.264 VGA video
 - 640 by 480 pixels
 - Up to 30 frames per second
 - AAC audio
- ⓘ Can you take photos? NO. There is no still camera option in the nano 5th Generation probably due to the low resolution of the VGA camera.

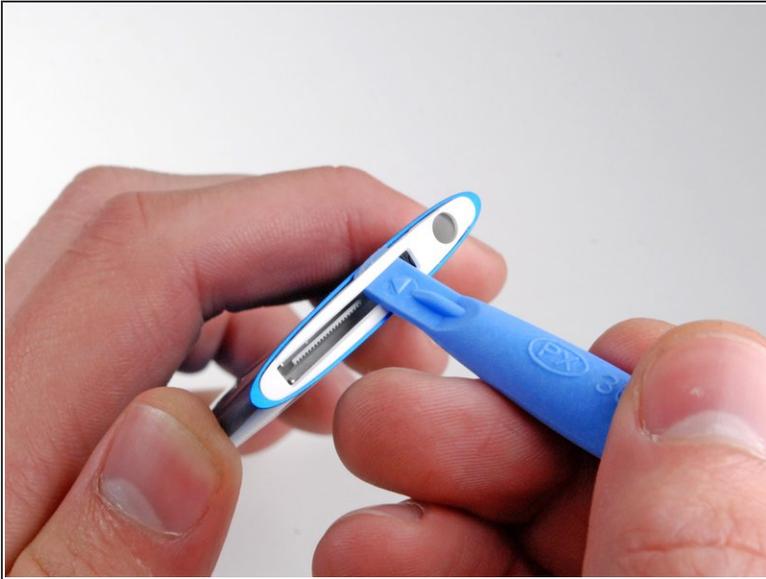
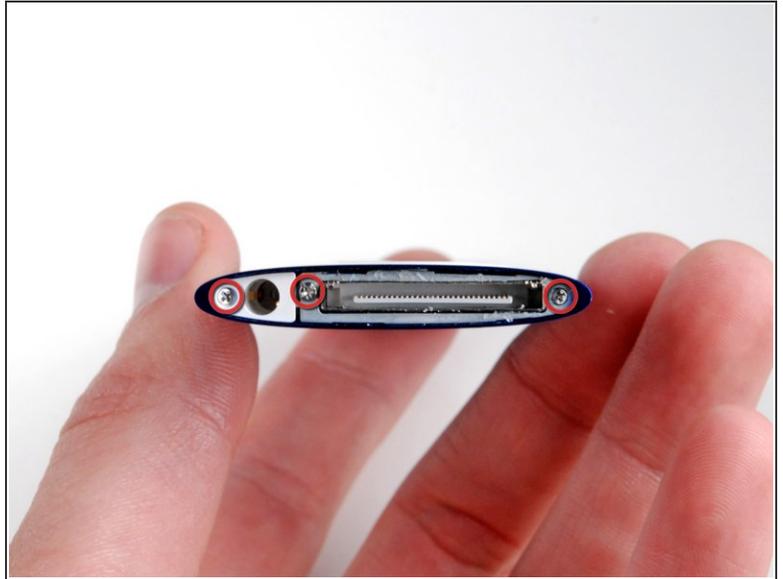
Step 4

- A Plastic Opening Tool makes quick work of the plastic bezel surrounding the dock connector.
- There's not much to see here yet. We're working on getting to the good stuff...
- So far, there's a lot in common with the [4th Gen nano](#).

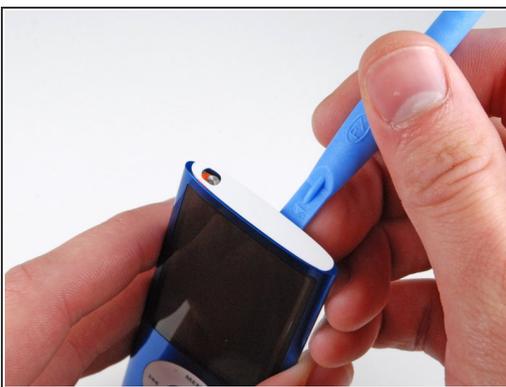
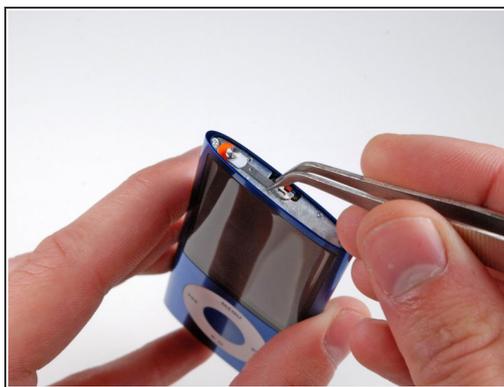
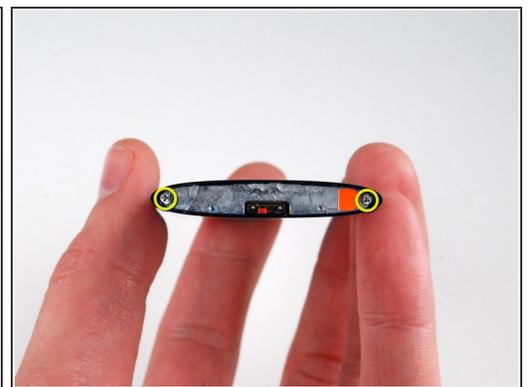
Step 5

- No surprises here. This design is identical to the 4th Gen nano. Even though the exterior hold switch is near the edge of the iPod, the internal hold switch is actually in the center of the iPod.
- ⚠ Shameless plug:** We sell hundreds of [iPod parts](#) for repairing your [iPod nano](#) or replacing an aging [iPod battery](#).

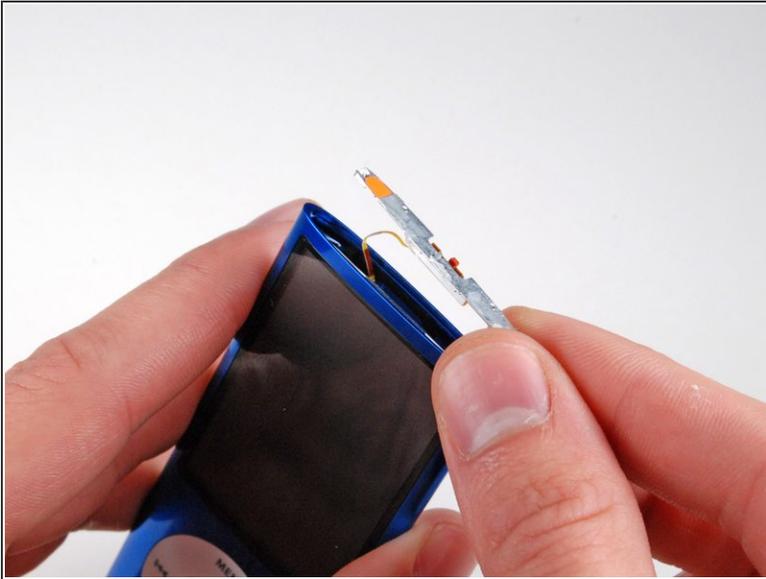
Step 6

- Unlike some earlier iPods, the hold switch isn't directly attached to the logic board.
- That's a really thin ribbon cable. Then again, there's not a lot of data that needs to go through it.

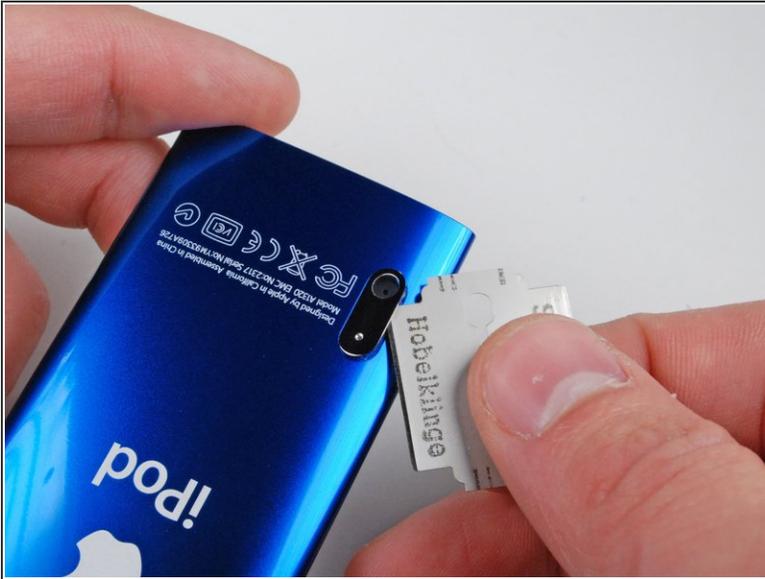
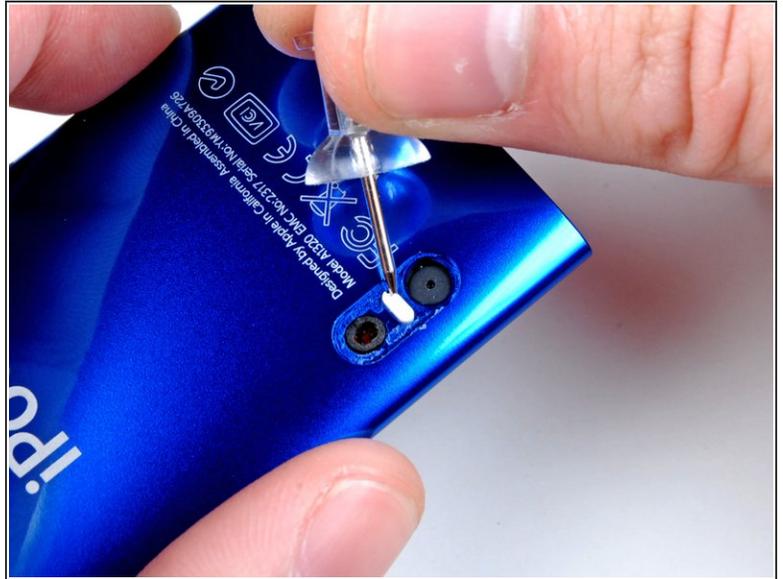
Step 7

- The camera bezel appears to be keeping the iPod's insides from coming out.
- Eine Deutsche Rasierklinge should fix that...
- The microphone by the camera ensures you get sound with your VGA moving pictures.
- Use a pin to remove the small white retainer from between the camera and microphone holes. This keeps the components from sliding toward the bottom of the nano.

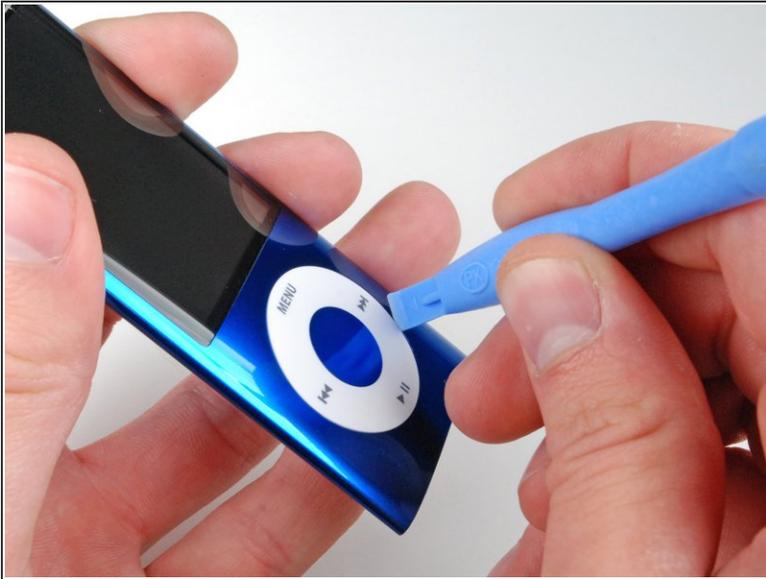
Step 8

- Apple has redesigned the click wheel on this nano. Instead of being (fairly permanently) affixed to the case, we were able to rotate and lift the click wheel.
- You can use a [spudger](#) to completely remove the click wheel without taking the rest of the iPod apart.

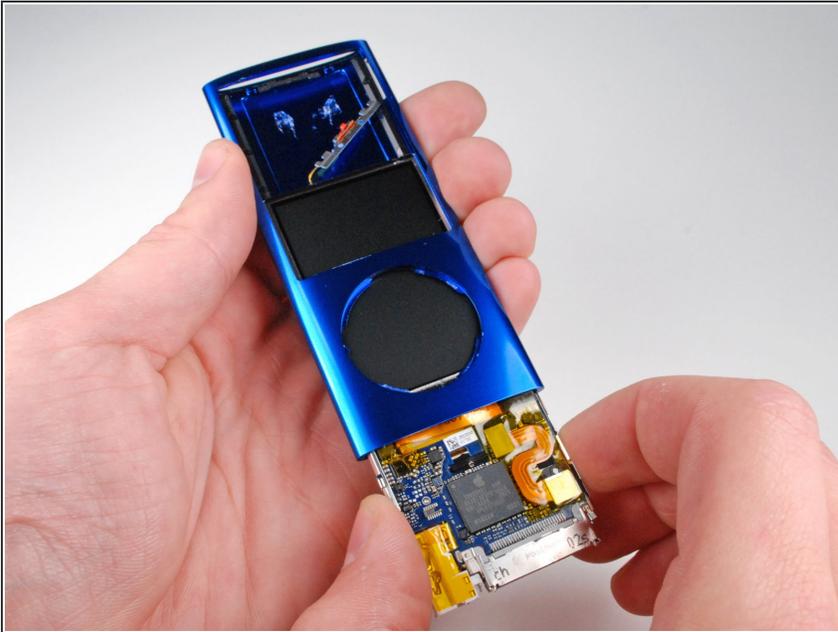
Step 10

- Removing the internals... It's a tight squeeze, but we got them out. Getting this iPod open wasn't easy. We don't recommend trying this at home. Take great care not to scratch the screen on the sharp recess for the click wheel, bend up slightly if necessary.
- ⓘ We wish Apple would put a little effort into making iPods repairable, instead of forcing people to [throw them away](#) when they break. Recent iPods have become increasingly difficult to successfully repair.
- This iPod employs copious amounts of glue and adhesive to hold everything together. That makes it easy for Apple to put together, but hard to take apart.

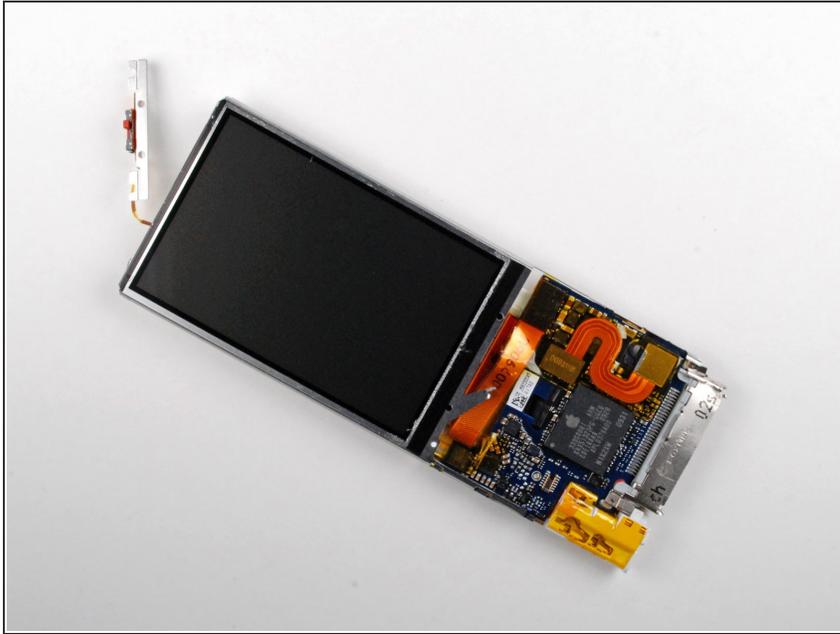
Step 11

- iPod, sans casing.
- The tolerances on this iPod are incredibly tight, there's no wasted space inside.

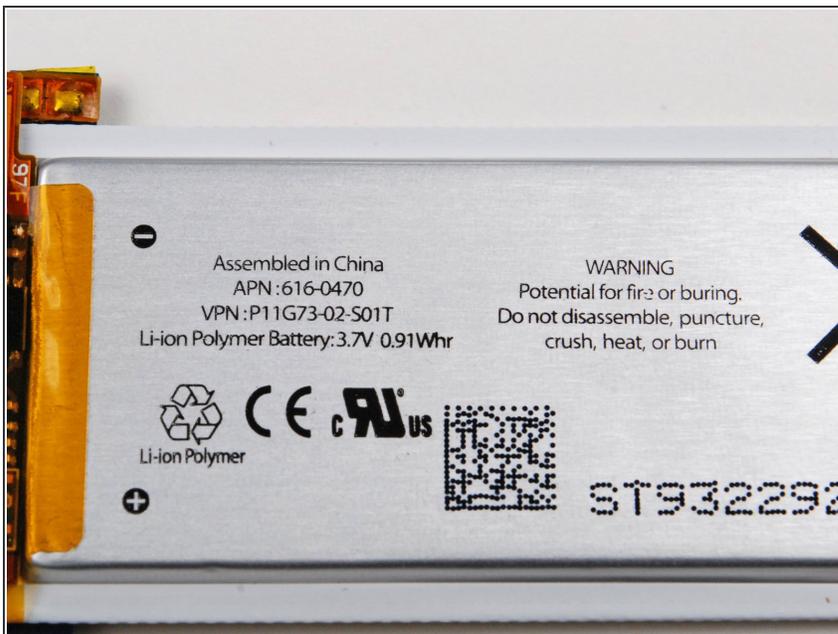
Step 13

- The battery. Apple warns you right from the get-go that your iPod may melt and/or spontaneously combust: "Potential for fire or burning." We assume they mean burning. It is assembled in China, so we'll give them a little slack.
- Supposedly if you burn this battery, it will burn.

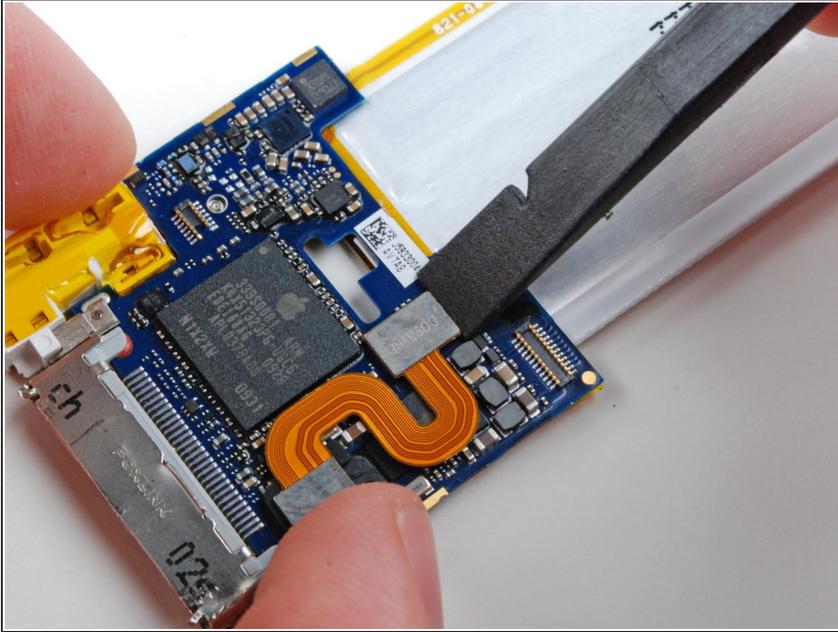
Step 16

- Removing the camera.
- It's nice to see that the camera's a separate module and not integrated into the board.

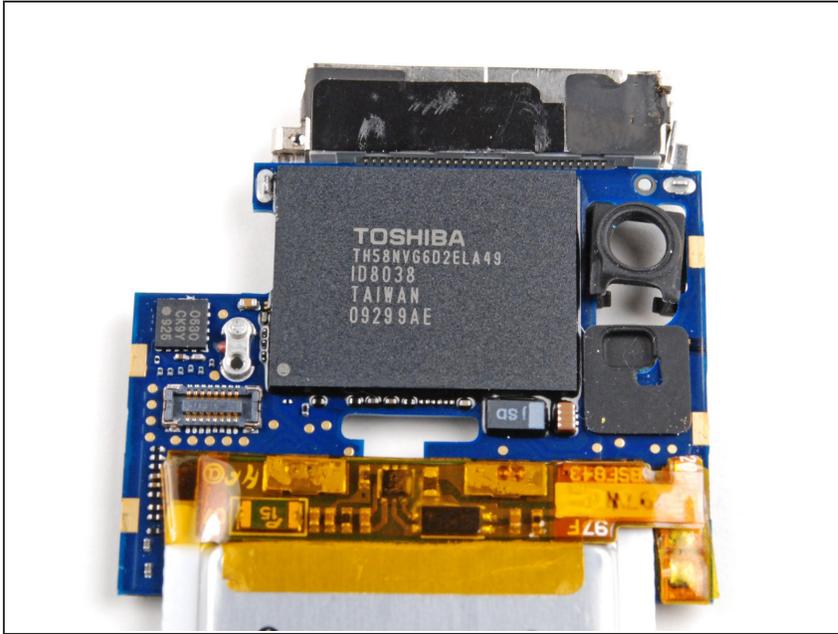
Step 18

- In our iPod, Toshiba is the source for the 8 GB of flash memory. On the chip:
 - TH58NVG6D2ELA49
 - ID8038
 - TAIWAN
 - 09299AE
- It looks like this was made in Taiwan in week 29 of 2009 (mid-July).
- Also visible to the right of the Toshiba chip is the rubber mounting fixture for the camera, assumedly to dampen vibrations.
