Toro Walk Behind Mowers 21199HD 2018 Right Blade Replacement

Guide to remove and replace the right blade on the Toro Walk Behind Mower 21199HD 2018.

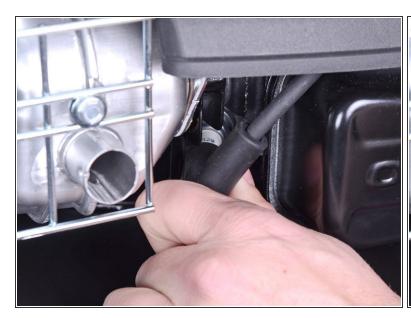
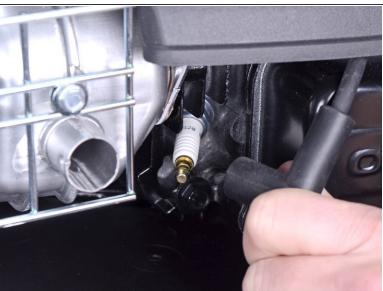
Step 1 — Disconnect the spark plug wire

- Refore you begin, ensure that the mower is powered down and cool to the touch.
- Grab the plastic housing at the end of the spark plug wire and pull firmly to disconnect it.

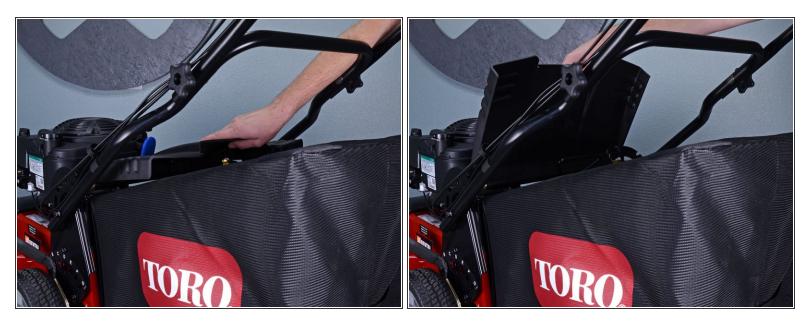
Step 3 — Lift up the deflector

Lift up the plastic deflector.

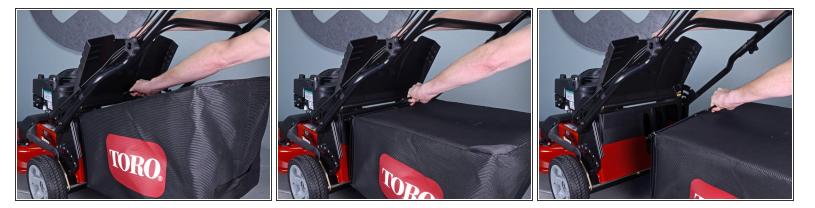
Step 4 — Remove the grass bag

- While holding the deflector up and out of the way, lift the grass bag handle away from the mower to detach it.
- Remove the grass bag.

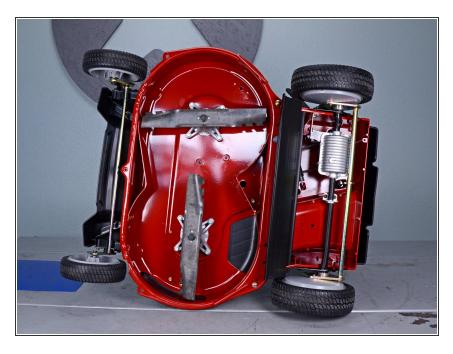
Step 5 — Tilt the mower on its side

- Tilt the mower onto its side so the blades are facing out.
 - (i) This may require two people.

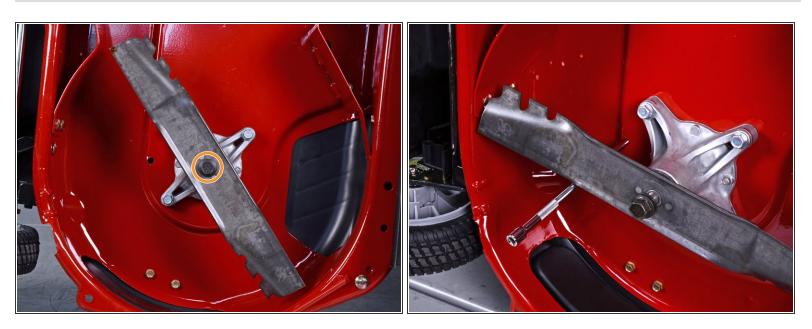
Step 6 — Remove the blade bolt

- Use an impact driver with a 5/8-inch socket to remove the right blade bolt.
 - (i) If necessary, brace the blade with a screwdriver or extension by placing it in the hole in the metal blade guard.

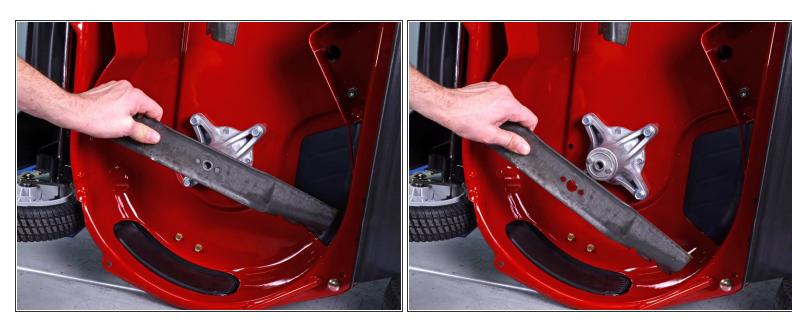
Step 7 — Remove the blade

- Remove the right blade.
- Mhen installing the new blade, ensure that it's in the correct orientation and direction.

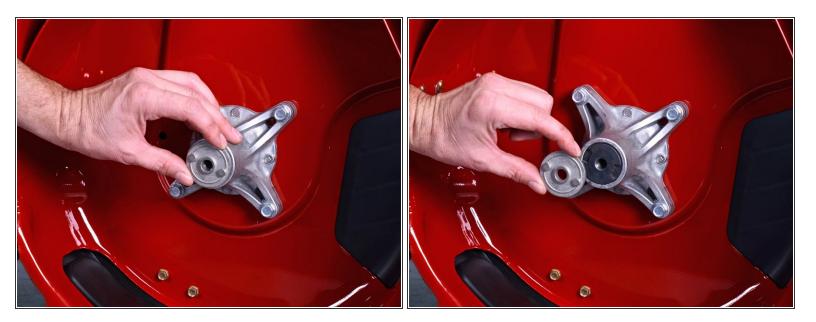
Step 8 — Remove the blade key adapter

Remove the right blade key adapter.

To reassemble your device, follow these instructions in reverse order.
