Audio-Technica AT-LP60BK-BT Belt Drive Replacement

Use this guide to replace the broken or missing belt drive for the Audio-Technica AT-LP60BK-BT Turntable.

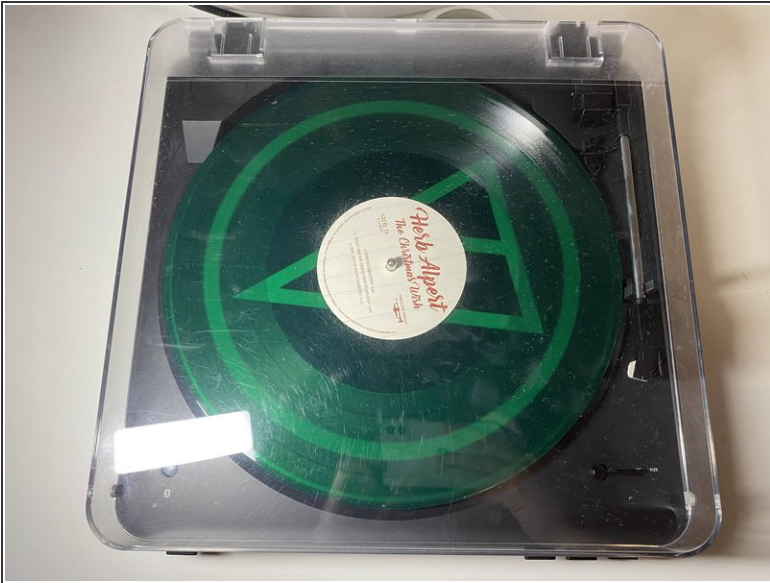
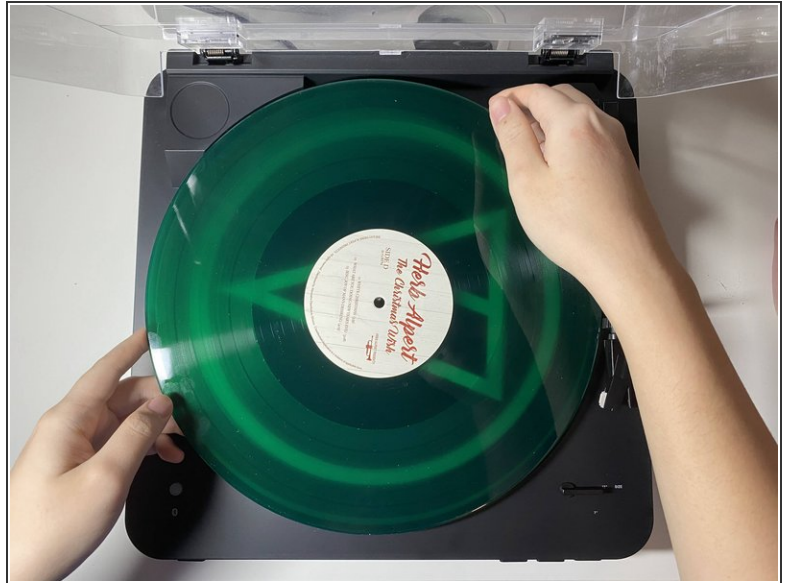
Step 1 — Belt Drive

- Open the top plastic cover and remove the record and rubber mat.

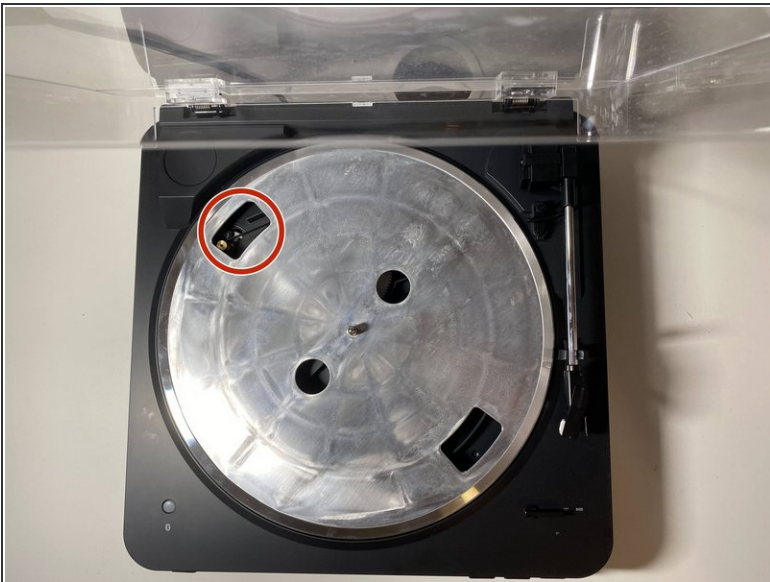
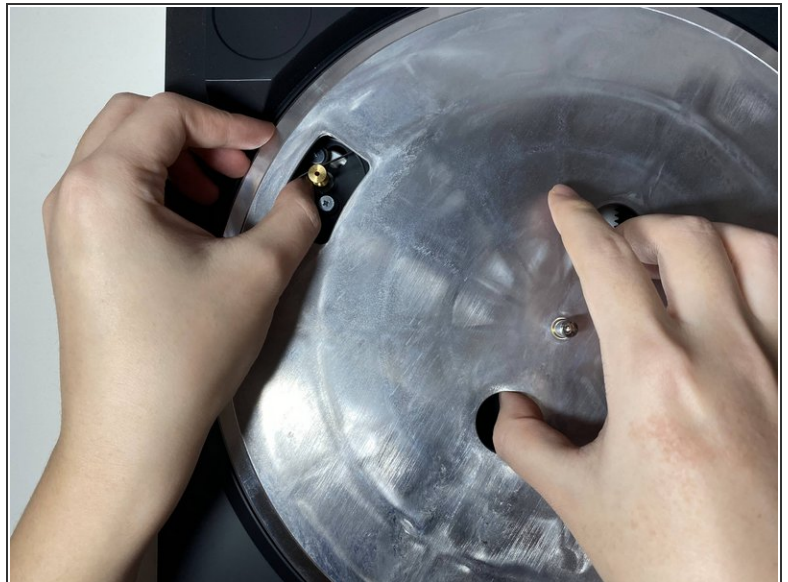
Step 2

- Find the belt underneath the platter by rotating the platter to the correct place.
- Remove the belt from the motor pulley.

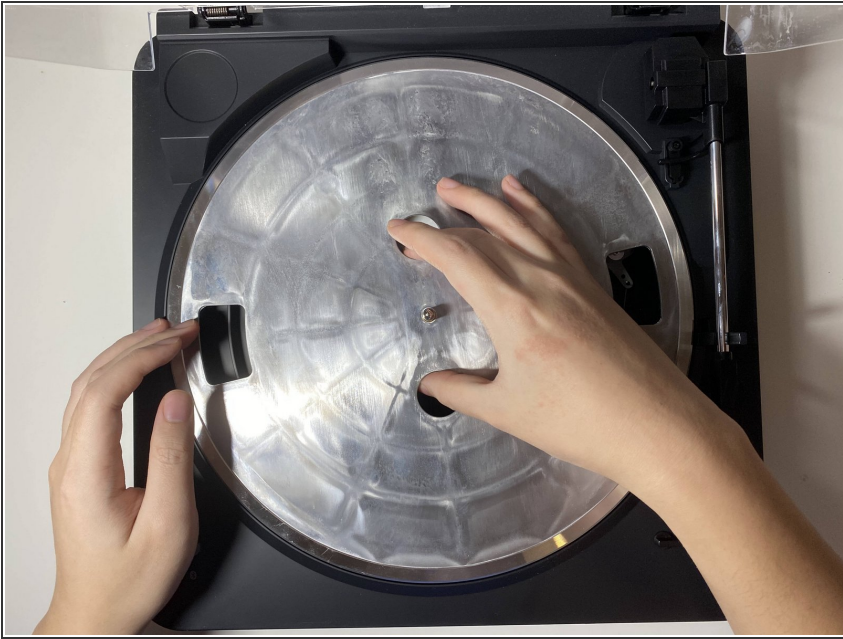
Step 3

- Take the platter off by pulling it straight up.

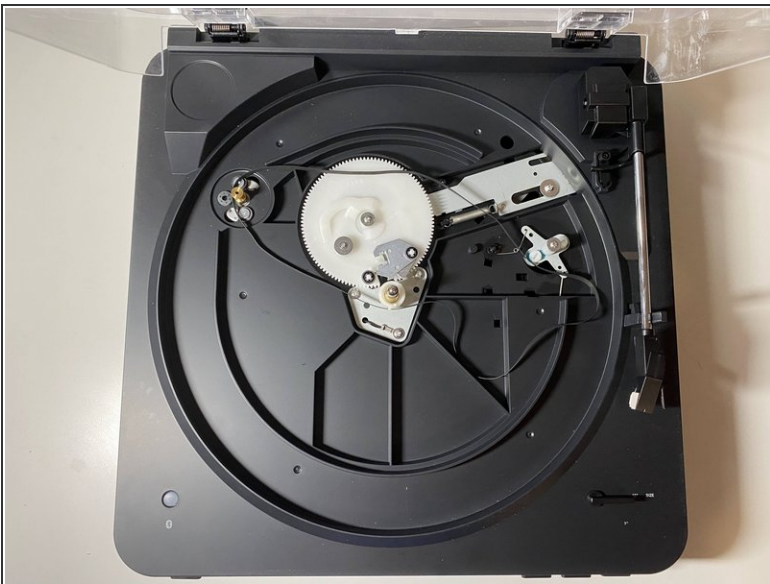
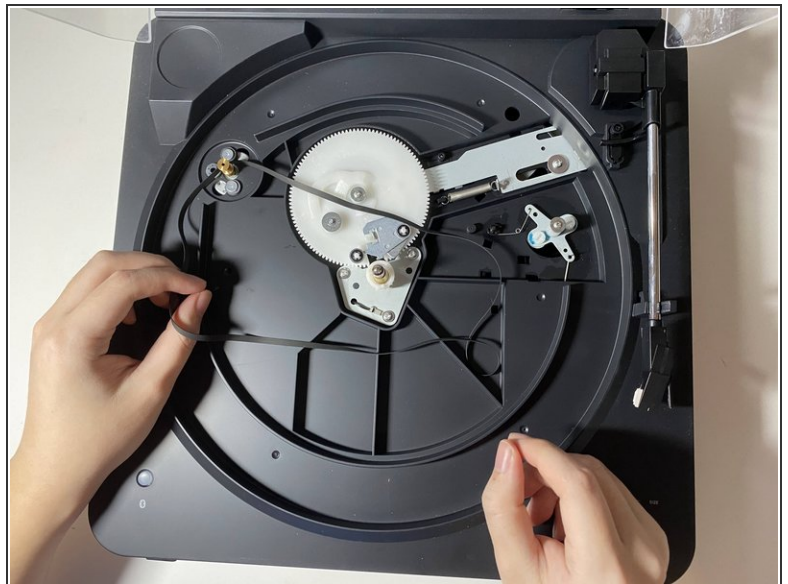
Step 4

- Remove the old belt.

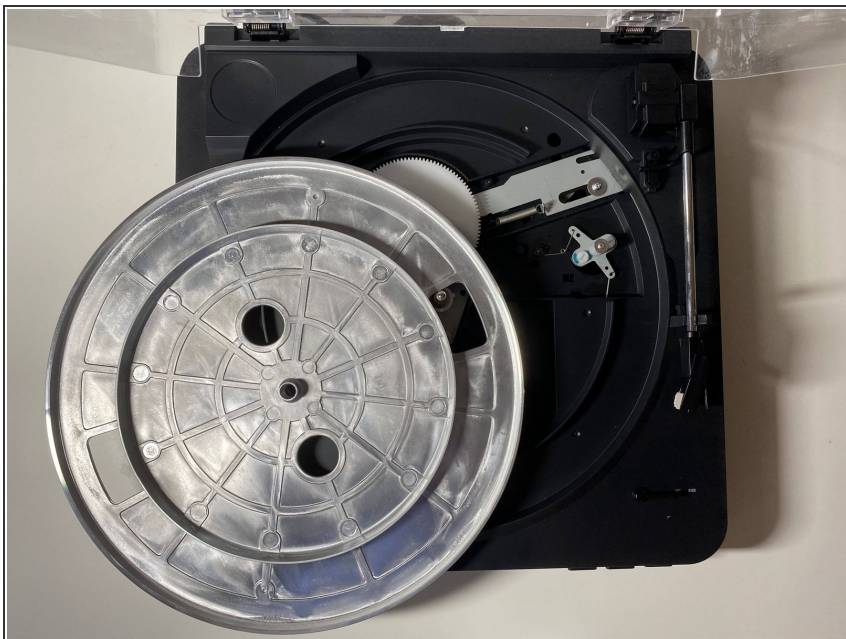
Step 5

- Turn platter upside down.

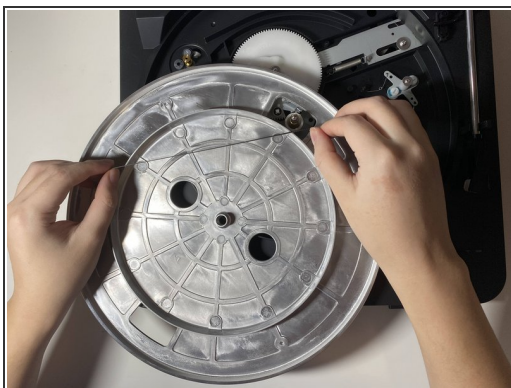
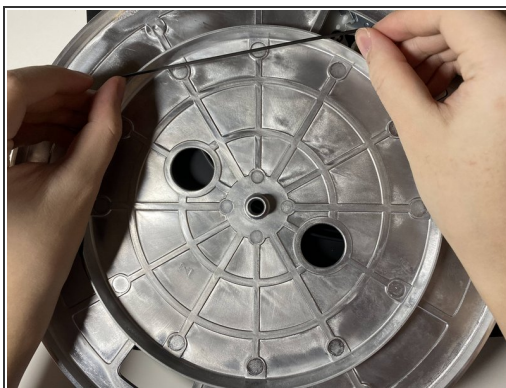
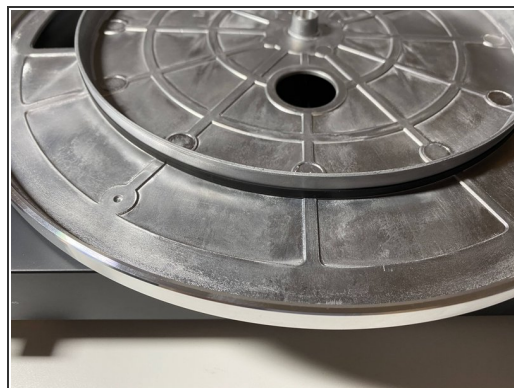
Step 6

- Place the new belt around the inner lap on the upside-down platter.

⚠ Make sure the rubber band is flat on the platter, with no flipping.

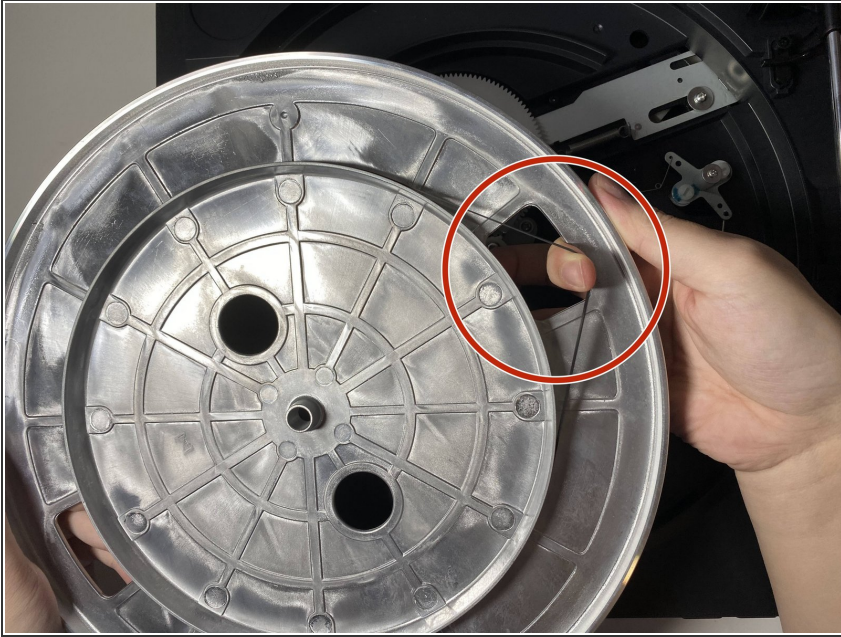
Step 7

- Turn the platter around.
- Grab the belt around with a finger through one of the holes in the platter.

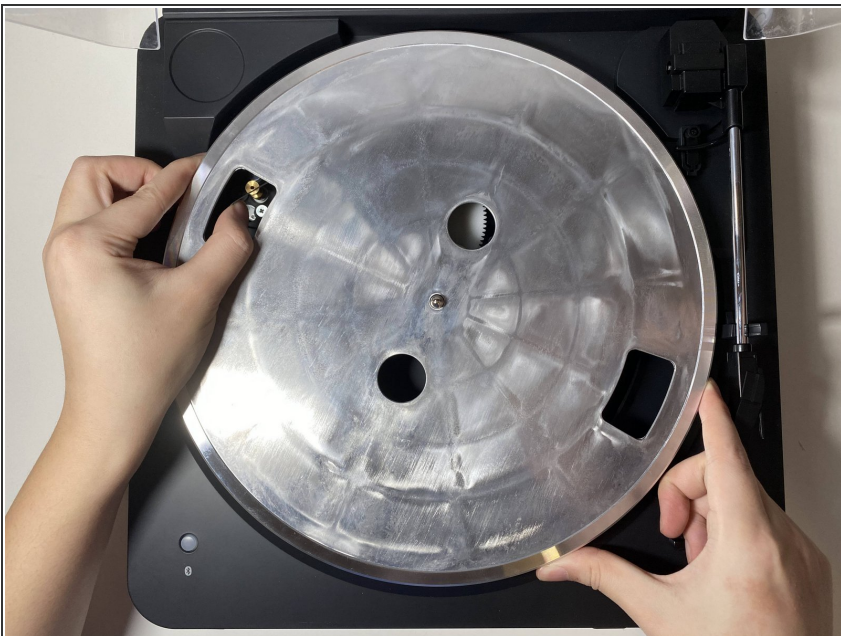
Step 8

- Put the platter straight down.

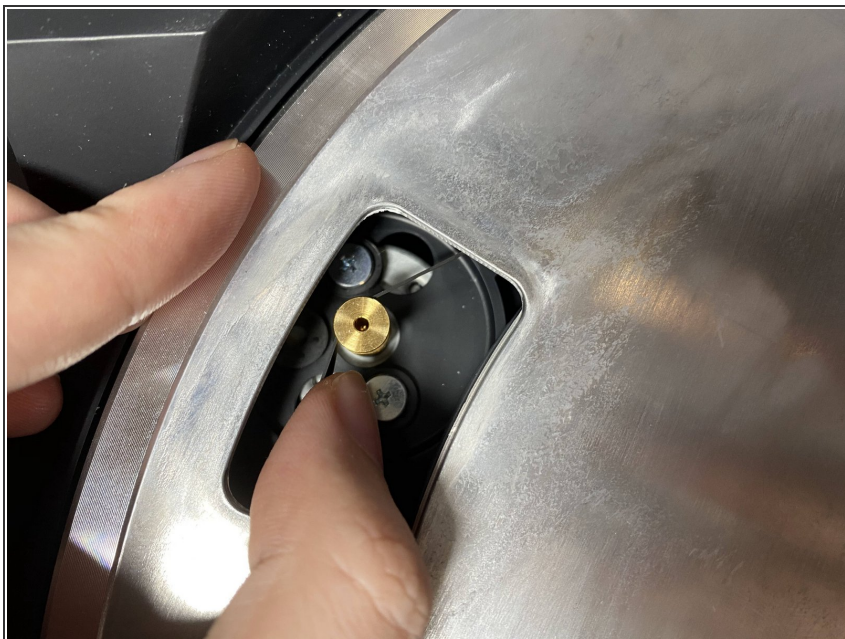
Step 9

- Put the belt around the motor pulley.

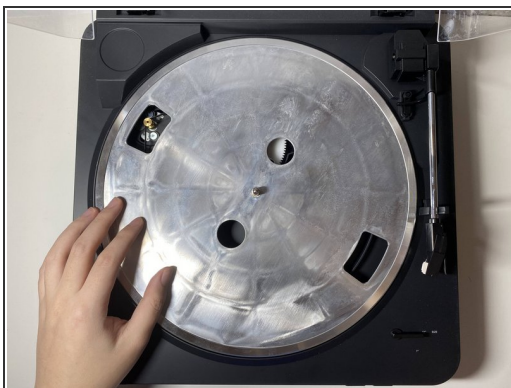
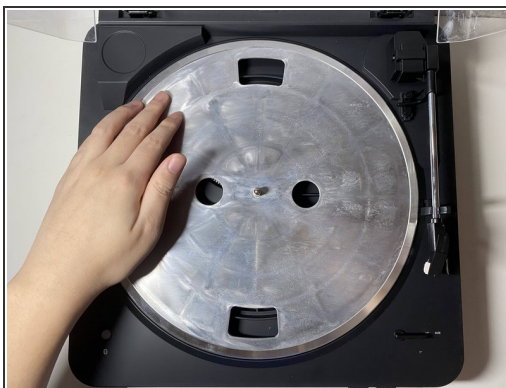
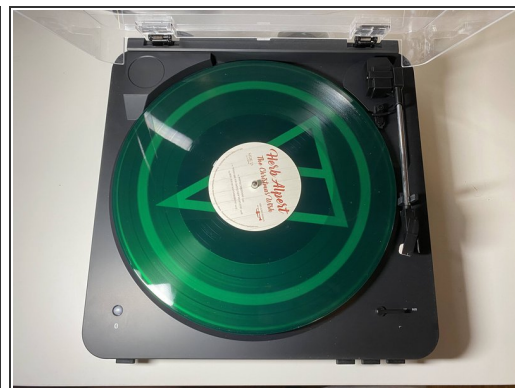
Step 10

- Test the function by spinning the platter and put the rubber mat into place.
