Sony XPERIA Tablet Z Volume Button Replacement

Step 1 — Removing back cover

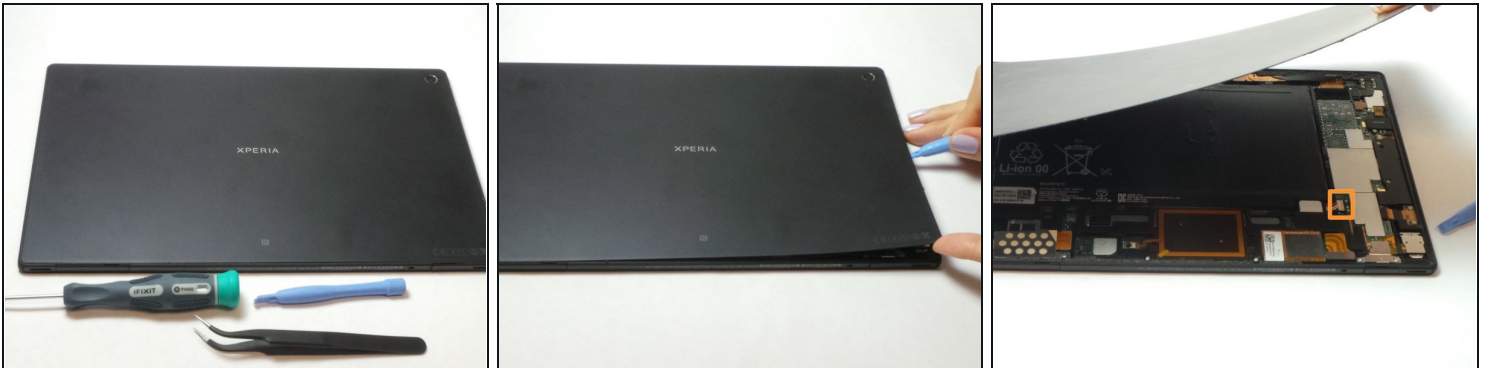
- Tools you will need is the Phillips #00 precision screwdriver, Plastic Opening Tools, and [tweezers](#).
- Insert plastic opening tool in the corner of device and slide along edges to separate adhesive.
- Remove cover
- Disconnect battery, to avoid electric shock, by pulling up on the white plastic as shown by the orange box.

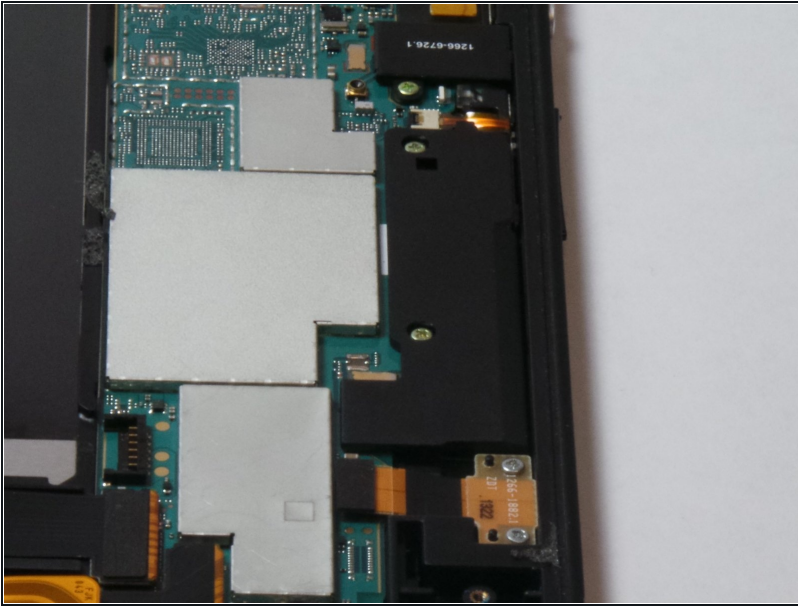
Step 2 — Locate the Volume module

- Locate the volume module.
- Remove both screws using the Philips screwdriver.

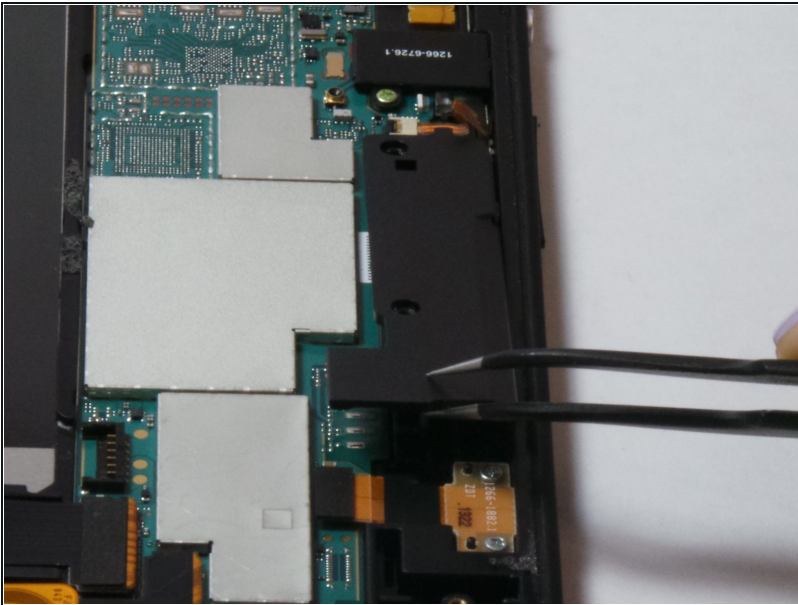
Step 3 — Lift out of Place

- Once both screws are removed grab the tweezers.
- Then lift up on the module.

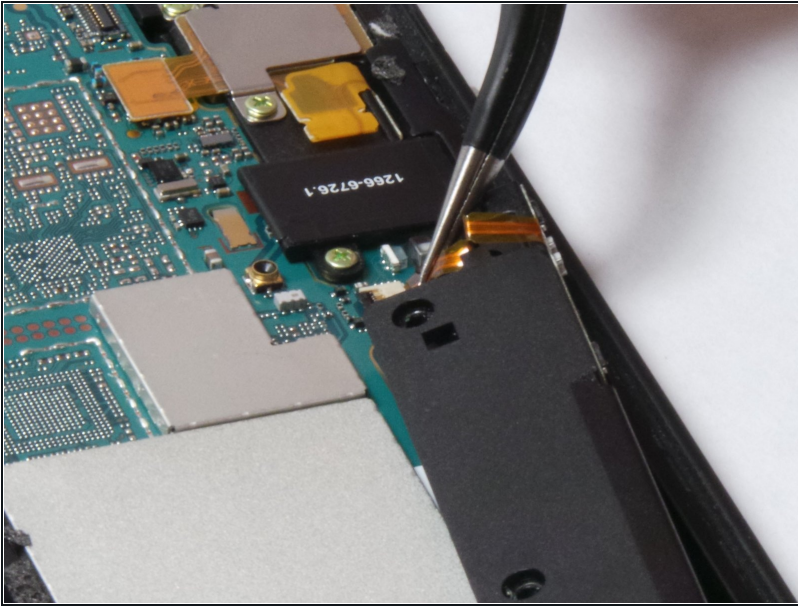
Step 4 — Removing the Electrical tape

- Find the electrical tape connecting the module to the motherboard
- Carefully pull out the electrical tape horizontally and remove the volume module from the device.
