Pebble Steel Vibration Motor Replacement

This is a guide to replace the vibration motor in a Pebble Steel Smartwatch.

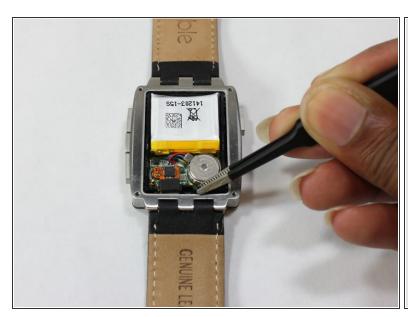
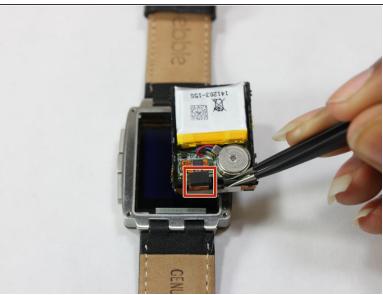
Step 2

- The plastic frame is clipped inside the steel body with four clips, two each on the left and the right side of the watch, near the corners. You can stick a small screwdriver into the cutouts right above the clips and gently lever the plastic frame up, corner by corner.
- Once the clips are released, use a pair of tweezers to grab onto the black plastic frame and remove the internal hardware.
- (i) Adhesive on the back side of the battery holds the internal components to the front case.
- Use tweezers or a plastic opening tool to disconnect the ribbon cable from the motherboard.

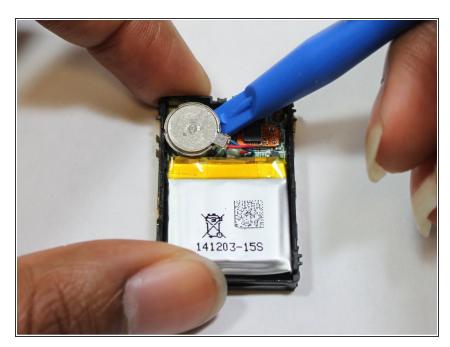
Step 3 — Vibration Motor

Use a small plastic opening tool to remove the vibration motor from the motherboard.

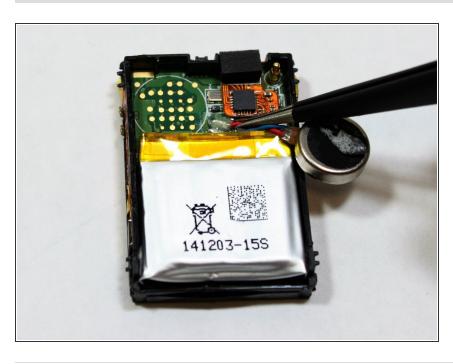
Step 4

Use a pair of tweezers to detach both the blue and red wires from the motherboard.
