## INTRODUCTION

## Step 1 — Amazon Tap Teardown

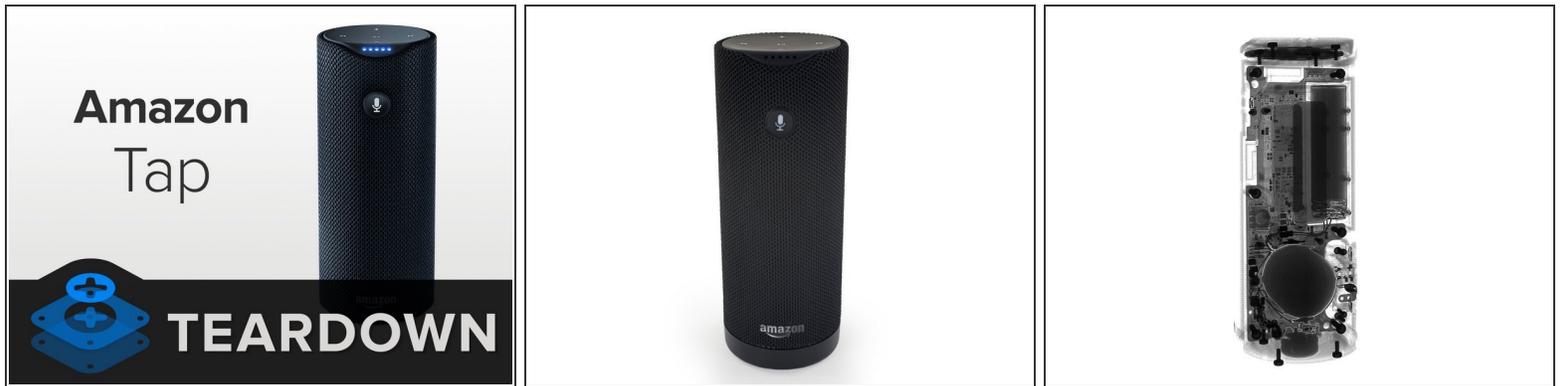
- This is Amazon's first portable, Alexa-powered device, so we're excited to see how they've switched things up. Features include:
  - Button-activated Alexa Voice Service
  - Up to 9 hours of audio playback on a single charge
  - Dual 1.5-inch drivers and dual passive radiators for bass extension
  - Single-band 802.11b/g/n Wi-Fi and Bluetooth 4.2
  - Charging cradle
- While we're sharpening our tools, here's a sneak peek via [X-ray](#).

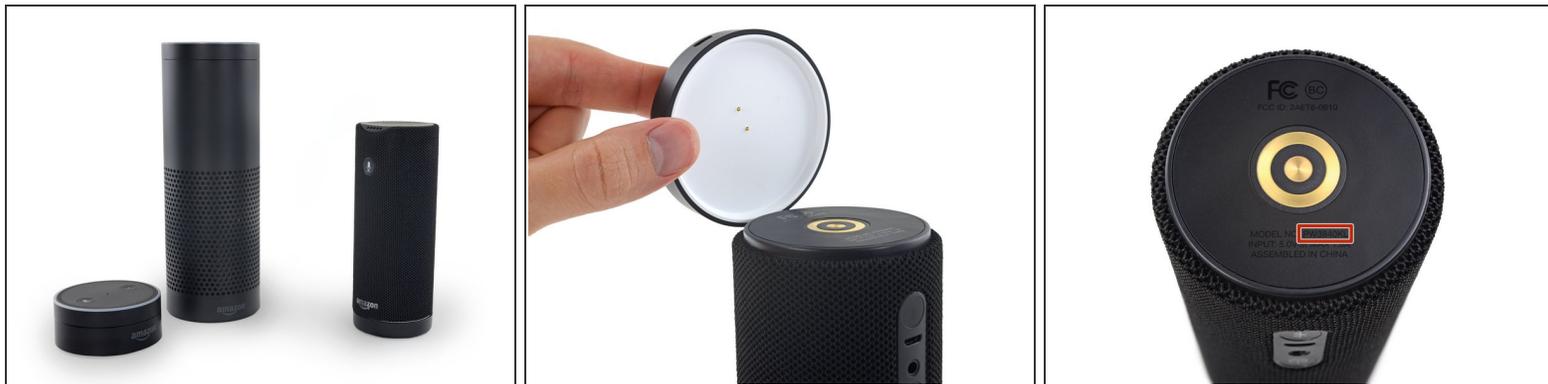
## Step 2

- *Faceoff!* On the right we have the Tap, and on the left, its wirebound siblings. Go on, guys, introduce yourselves.
- Tap's charging cradle sports two spring contacts that connect to the base at any angle, thanks to this target-shaped pair of circular contacts on the bottom of the Tap.
- Taking a closer look, we see Tap's model number, PW3840KL, alongside all the usual suspects.

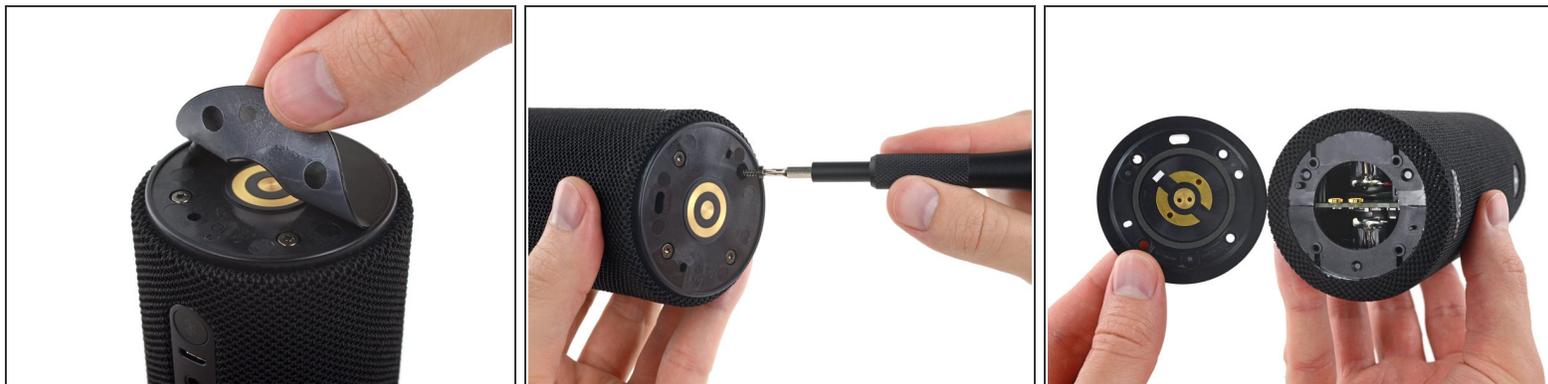
## Step 3

- With a couple other cylindrical Amazon teardowns under our belt, we know the drill. The first piece out of this puzzle is the base's rubber footing.
- Seconds later, a few T9 Torx screws bite the dust, and we get our first look inside.

**⚠ It's just a peek, though—our path forward is blocked by the molded plastic housing. Time to check for other possible points of entry.**

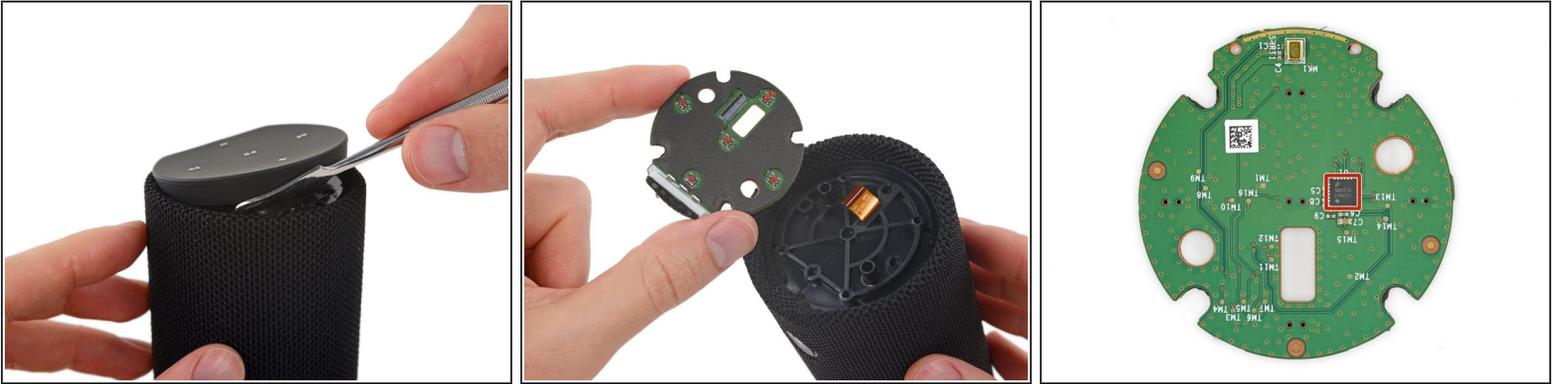
## Step 4

- Undeterred, we turn our ~~attention~~ spudger to the rubberized control panel at the other end.
- With some assertive prying, the plastic clips give way to reveal a control button breakout board featuring some buttons, a microphone, and a lone IC:
  - National Semiconductor [LP55231](#) Programmable 9-Output LED Driver (as seen in the [Echo](#) and [Echo Dot](#))
- Unfortunately, there are no fasteners lurking at this end either. Time to get ~~creative~~ destructive!

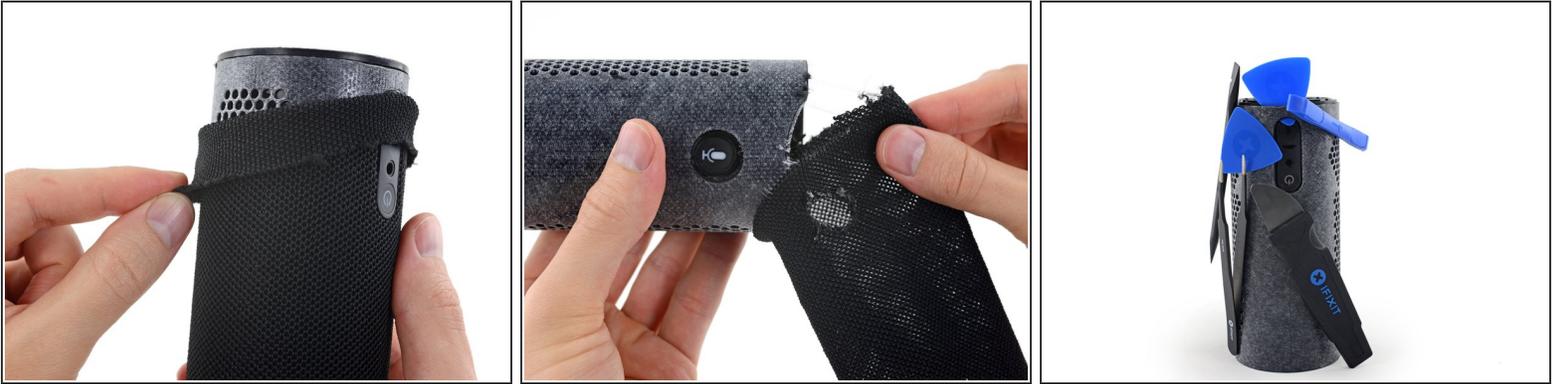
## Step 5

- Thwarted by a lack of screws at either end, it seems that there's no easy way to Alexa's heart. So, let's do things the hard way.
- First off of the Tap's cowling is the stretchy fabric wrap, which we unroll from the cowling's firmly adhered outer surface.
  - Aaaaand still no screws.

**⚠** What we have here is a sticky situation. Many a brave pry tool met its doom attempting to bypass the Tap's flypaper exterior.

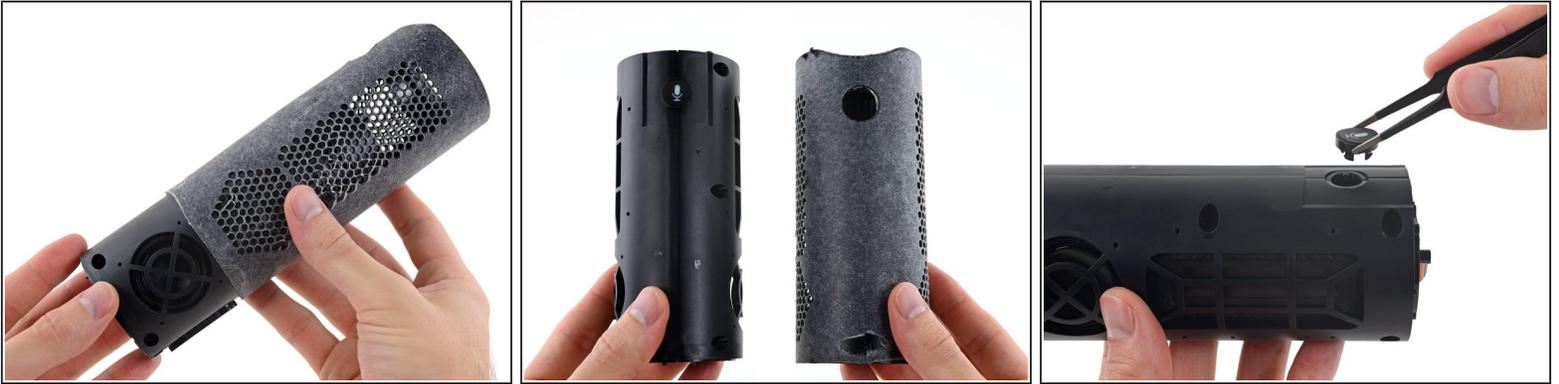
## Step 6

- After a good amount of finagling, we finally manage to wriggle the cowling free by sliding it over the power, Bluetooth, and microphone buttons.
- It may not look like progress, but it is. Just a few screws stand between us and those Taptastic interior goodies.
- Suddenly the microphone button comes out all willing-like. That would have been helpful in the *prior* step, but we'll take it!

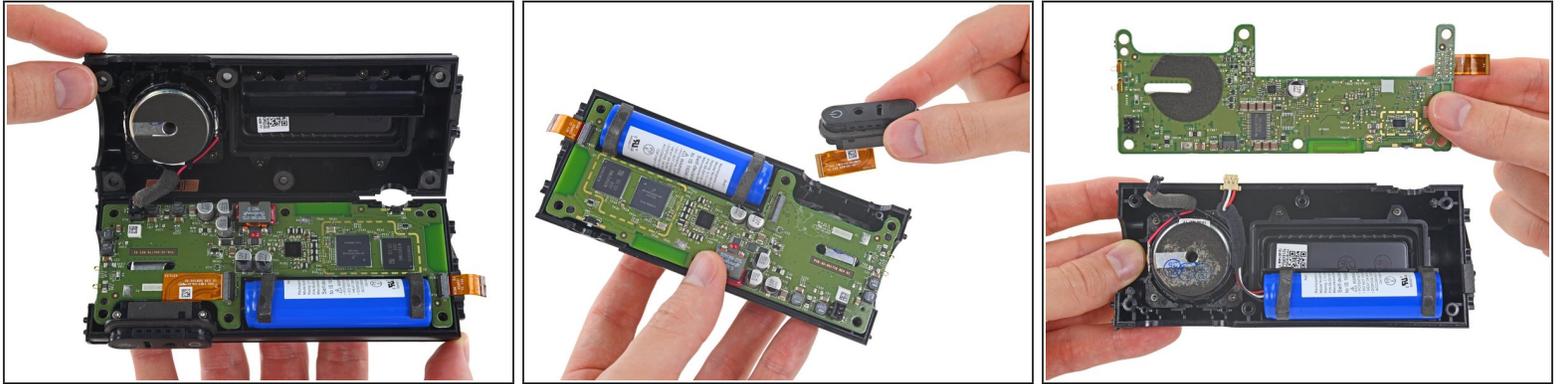
## Step 7

- With the sheath shucked and a handful of screws dispatched, the Tap falls open like a book.
- And things are looking up! The I/O panel, mounted by way of a couple screws, attaches to the motherboard via a flex cable *and* slides right out.
- ⓘ That means replacing the USB port, a commonly failing component in mobile devices, will be possible if not totally painless.
- Moving right along, the motherboard jumps out to join the party.

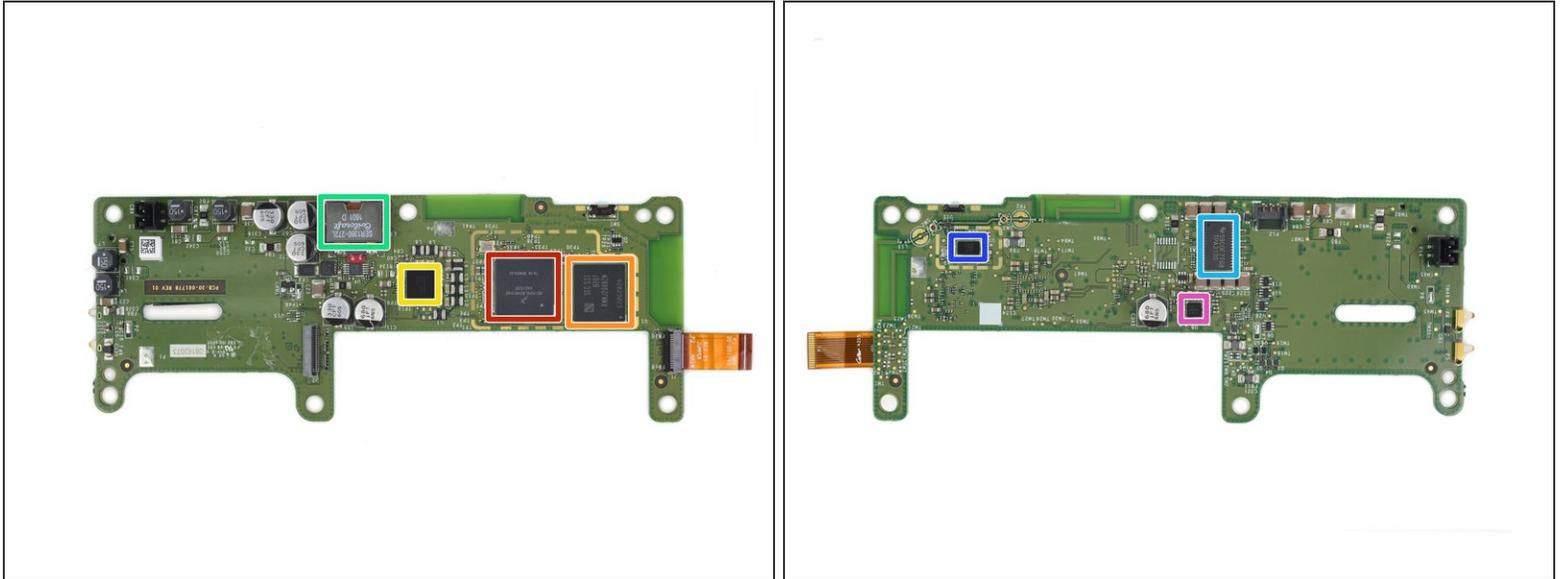
## Step 8

- Reaching the brains of this smart speaker, we do our due diligence and identify all the key players:
  - Freescale/NXP [MCIMX6L8DVN10AB](#) i.MX 6SoloLite Applications Processor
  - Samsung KMNJ2000ZM-B207 512 Mb DDR2 SDRAM Memory (likely)
  - Maxim MAX77697 PMIC
  - Coilcraft [SER1360-272L](#) High Current Shielded Power Inductor
  - Texas Instrument [TPA3130](#) 15W Filter-Free Class D Stereo Amplifier
  - Broadcom [BCM4343](#) Wi-Fi and Bluetooth 4.2/Bluetooth Smart SoC
  - Maxim [MAX98090](#) Ultra-Low Power Stereo Audio Codec

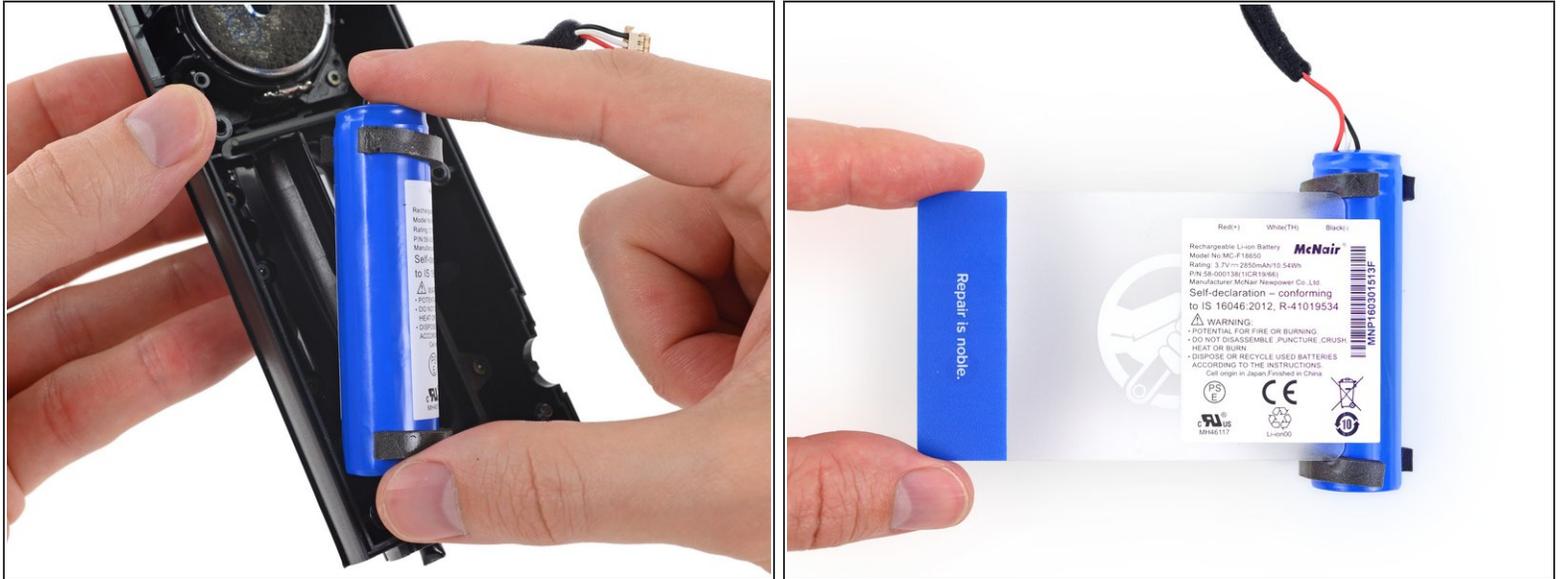
## Step 9

- Next to come out is a standard 18650 Lithium Ion cell, widely used in the industry from [Tesla](#) vehicles to [self-balancing boards](#).
- ⓘ This unit is rated for 2850 mAh at 3.7 V to yield 10.54 Wh, which Amazon says will provide up to 9 hours of music playback.
- Compare that with the 3.8 V, 2750 mAh, 10.45 Wh battery in the [iPhone 6s Plus](#)—a battery with a similar output for a radically different job.

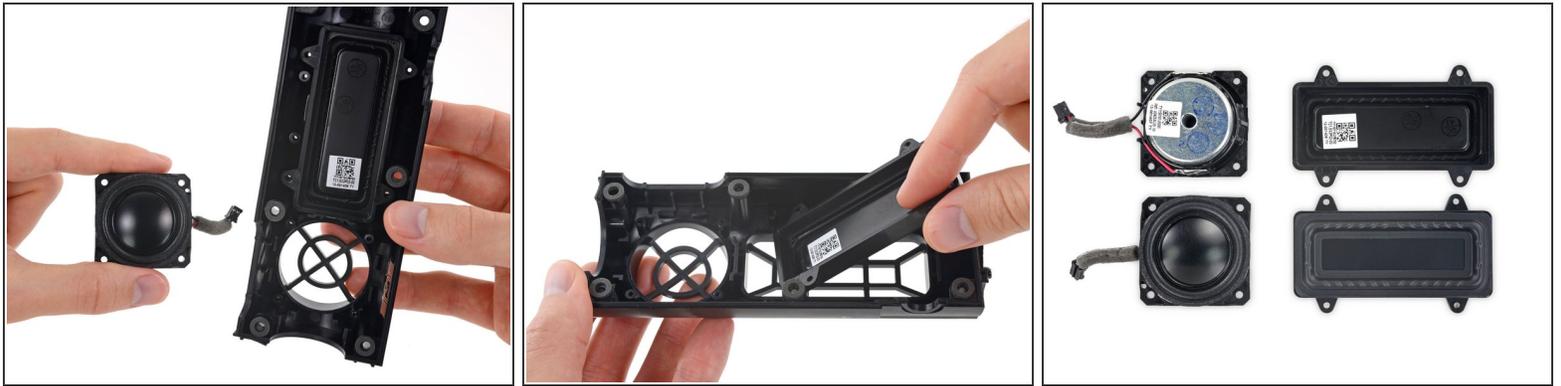
## Step 10

- We're down to the real heavy hitters: the speakers!
- These little 1.5-inch drivers each pair with a larger [passive radiator](#) to improve lower end frequency response without additional large drivers or a base response tube.

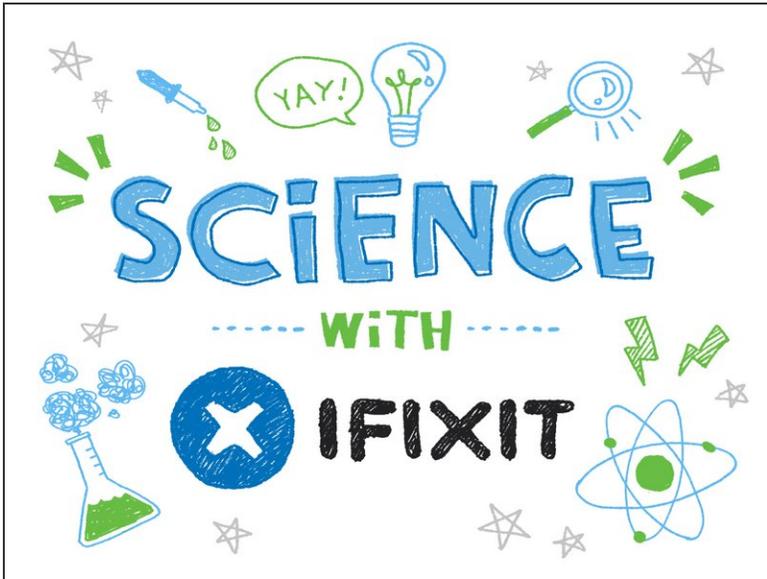
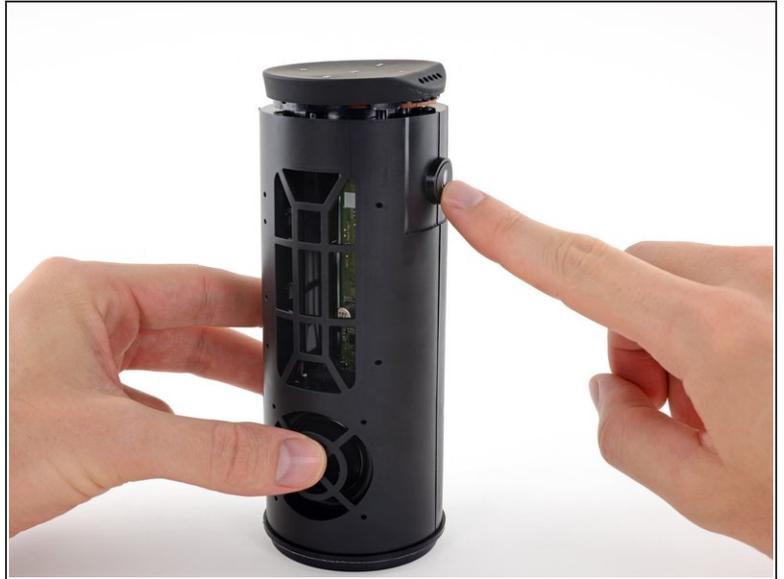
## Step 11

- Okay but seriously, those passive radiators aren't even connected to anything. How important could they be?
- We thought you'd never ask. What we have here is a reassembled Tap with a conspicuous absence of passive radiators. So how does it sound?
- In a word, *bad*. Just for kicks, we ran a [audio spectrum test](#) with the passives out, and again with them in. Our puny human test subjects couldn't even hear the signal below 120 Hz—until we reinstalled the passive radiators, at which point they confidently identified a bassy rumble all the way down at ~90 Hz.
- Good job, passive radiators.

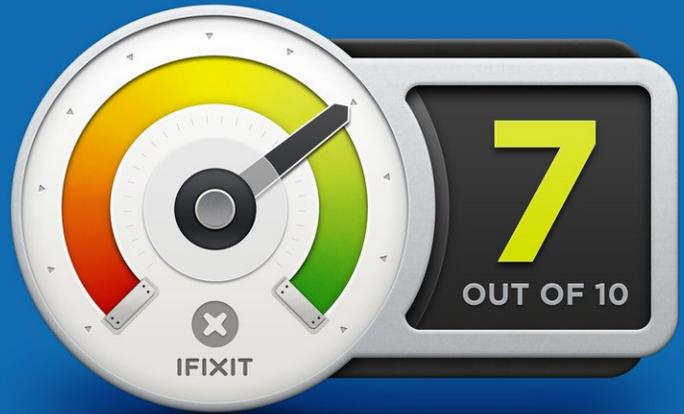
## REPAIRABILITY SCORE:

- Amazon Tap Repairability Score: **7 out of 10** (10 being the easiest to repair)
  - The battery, control board, I/O board, and speakers all connect to the motherboard via standard cable connectors.
  - Most components are held in with easily-undone clips or standard screws.
  - Removing the cowling requires a significant amount of force, but it is a nondestructive process.
  - Repairs are straightforward *if* you know your way in, but could be daunting without a service manual.
  - Tough adhesive holds the rubber footing to the base.
