Lorex LW2742 Microphone Replacement

Replacing the microphone on your Lorex LW2742 security camera.

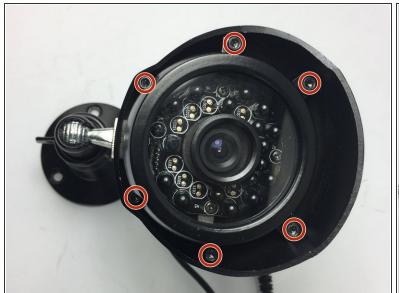
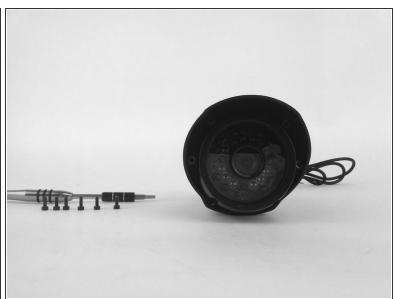
Step 1 — Microphone

Remove the six 10mm Torx T10 screws on camera face.

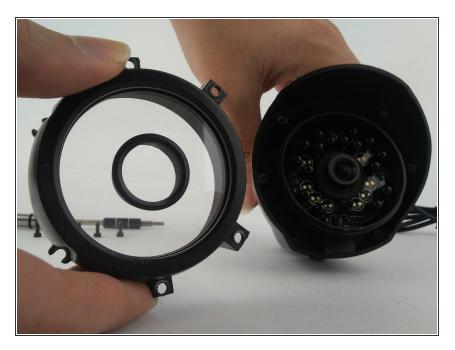
Step 2

Remove the exterior lens cover.

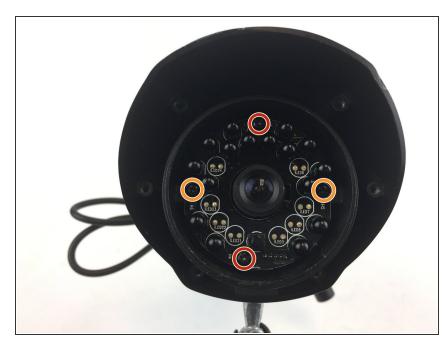
Step 4

- Remove the two 5mm Phillips #1 screws.
- Remove the two 8mm Phillips #0 screws.
- When reassembling, tighten the left and right 8mm screws first. Followed by the top and bottom 5mm screws.

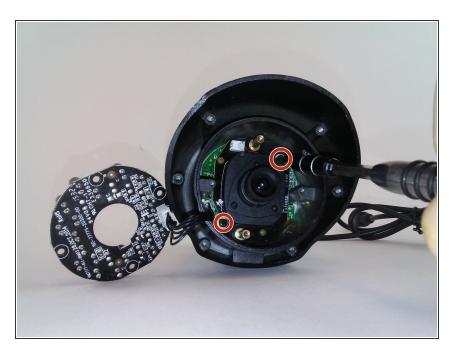
Step 5

Remove the two 5mm Phillips #1 screws.
