# Microsoft Band 2 Battery Replacement

Removing the Microsoft Band 2 battery

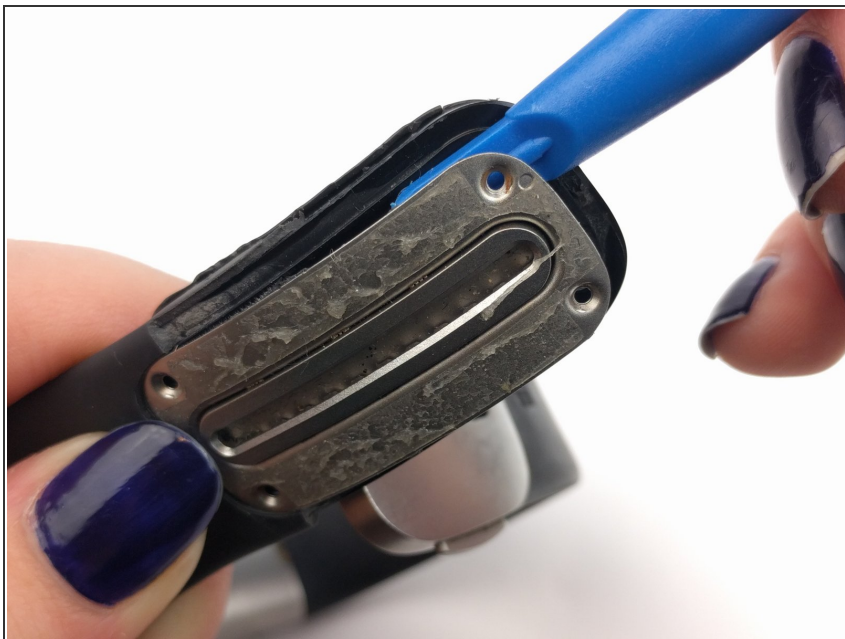
### Step 3

- Use the plastic opening tool to pry off the metal cover plate.
